# UPDATE Technical Bulletin

## UPDATE – 90H2 Instrument Cluster (NVLW)

Model(s)	Year	Engine Code	Trans. Code	From	To
Jetta Sedan	2012 – 2013	All	All	3VW__AJ_CM033700	3VW__AJ_DM386273

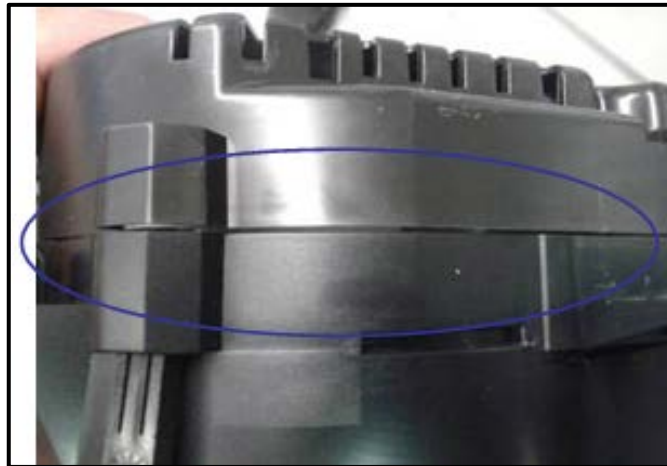
Picture 1

Since the lower housing does not fit properly with the upper housing, the buttons do not make contact when time and/or trip meter is being set. See Picture 1.

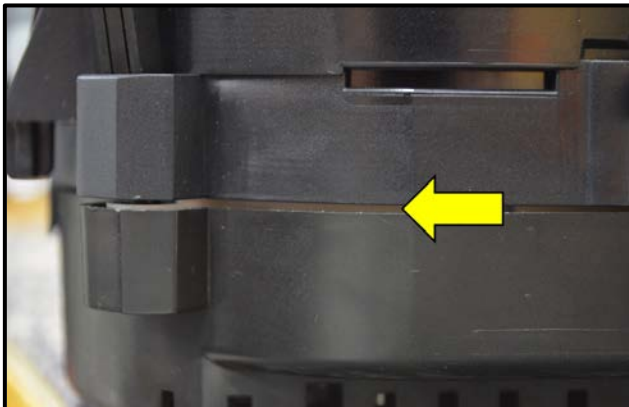
- With the instrument cluster removed from the vehicle inspect the seam between the two instrument cluster halves <arrow>.

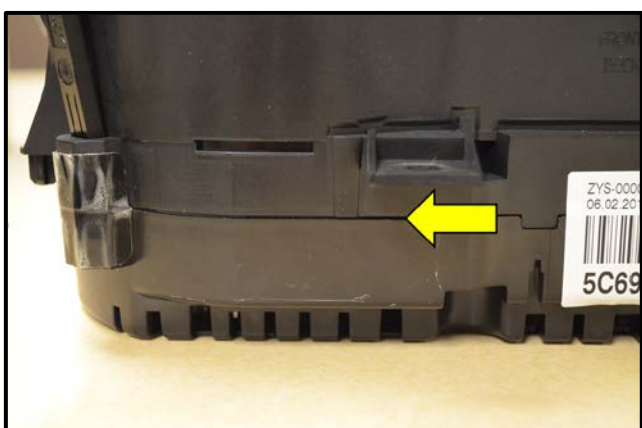
- ⇐ Inspect instrument cluster thoroughly to ensure both halves are fully seated and fastened together <arrow>.

With the repair complete, the seam gap will be approximately 1mm.
