Service Bulletin

Bulletin No.: 12-05-23-001

Subject: Pulsation or Vibration Felt in Steering Wheel During Moderate Brake Apply at Highway Speeds

Models: 2013 Cadillac XTS Limo (RPO V4U, W30) Hearse (RPO B9Q) Armored Car (RPO B05) Models

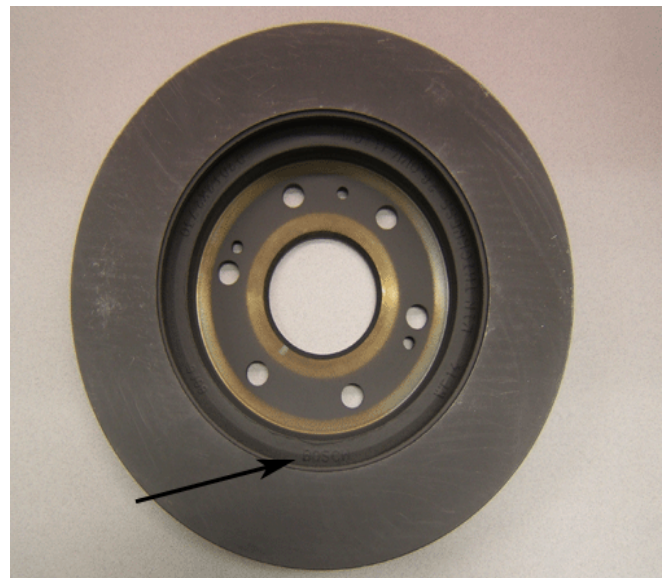
2405974

- It is critical to use the proper OEM brake rotors. Use of Non-OEM rotors may prevent the condition from being corrected long term.
 - If Non-OEM rotors are identified, these rotors are **NOT** covered under the GM New Vehicle Limited Warranty.
1. Inspect the front brake rotors to ensure that they are OEM rotors.
 - Remove the brake rotor from the vehicle.

- Inspect the back side of the rotor for the Bosch Logo. If the Bosch logo **IS NOT** present, replace with OEM GM rotors, P/N 25819670.
2. Inspect the front brake rotors for Assembled Lateral Runout (LRO) and thickness variation. Follow SI procedures.
 3. Inspect the front brake rotors for minimum thickness. Follow SI procedures.
 4. If the rotors are within specifications, **DO NOT** refinish or replace the rotors.
 5. If the rotors are out of specifications, refinish the rotors on a qualified lathe, or replace the rotors as appropriate. Follow SI procedures.
