Recall Bulletin

F/CMVSS NONCOMPLIANCE RECALL

SUBJECT: Rear Seat Head Restraint May Not Lock in Upright Position

MODELS: 2013 Cadillac XTS

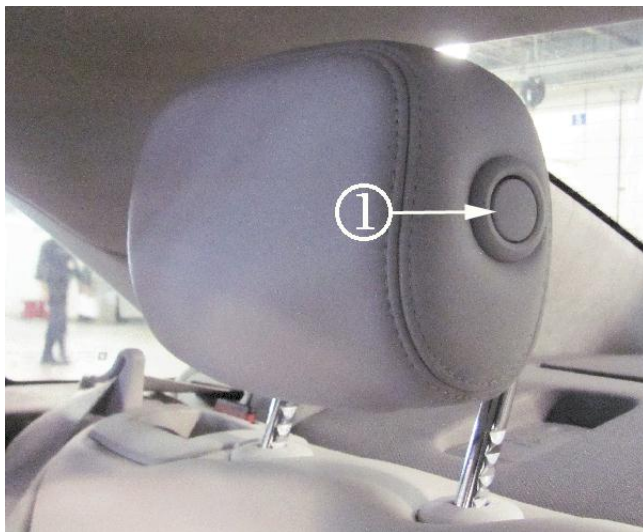
2964026

1. Verify that the rear seat head restraint is in the upright seating position.

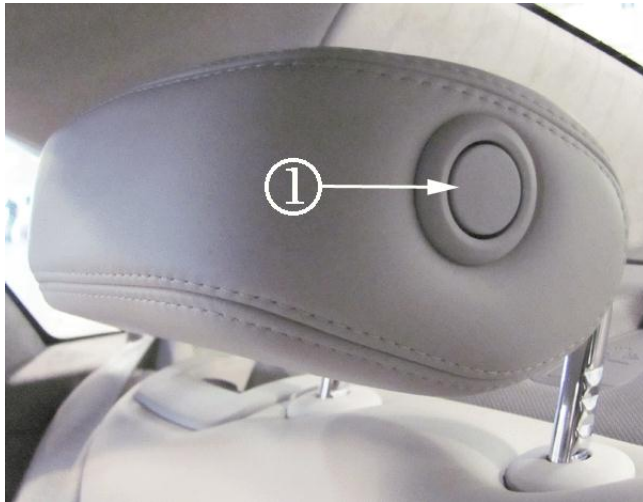
2964027

2. Push rear seat head restraint release button (1). Depressing the rear seat head restraint release button allows the rear seat head restraint to be folded.
3. Ensure the rear seat head restraint folds down after depressing the rear seat head restraint release button (1).
4. Verify that the rear seat head restraint release button returns fully from the depressed position.
 - If the rear seat head restraint release button returns fully from the depressed position, proceed to Step 5.
 - If the release button does NOT return from the fully depressed position, the rear seat head restraint will remain unlocked and will NOT stay in the upright seating position. Replace the rear seat head restraint if it will NOT remain in the upright seating position. Refer to *Rear Seat Head Restraint Replacement* in SI. Begin this inspection again on the second head restraint.

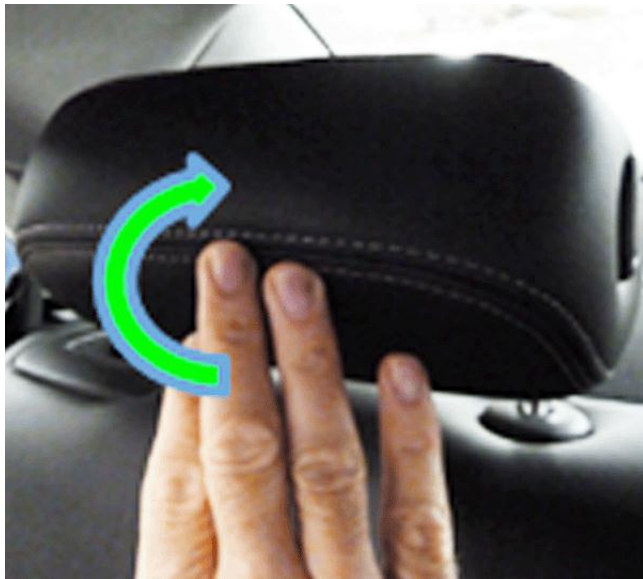
2964030

5. Cycle rear seat head restraint into the upright seating position.

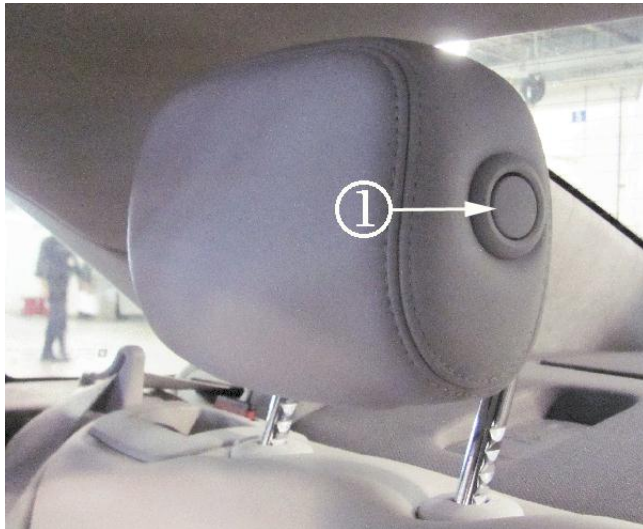
2964026

6. Verify that the rear seat head restraint release button returns fully from the depressed position.
 - If the release button returns fully from the depressed position, proceed to Step 7.
 - If the release button does NOT return fully from the depressed position, the head restraint will remain unlocked and will NOT stay in the upright position. Replace the rear seat head restraint if it will NOT remain in the upright seating position. Refer to *Rear Seat Head Restraint Replacement* in SI. Begin this inspection again on the second head restraint.

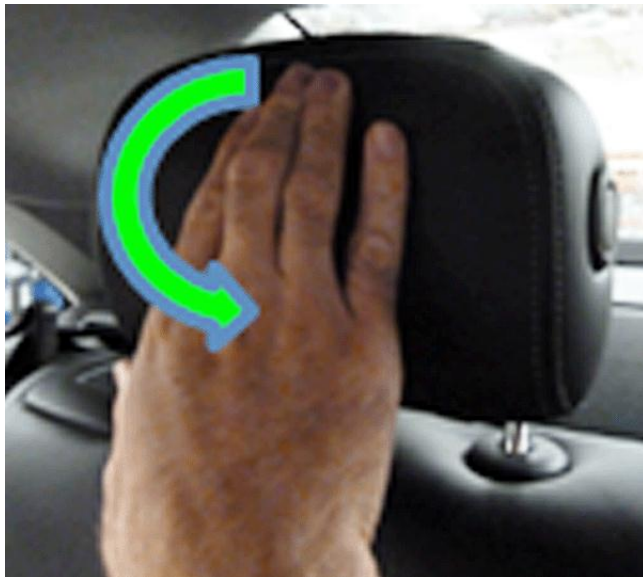
2964032

7. Verify that the rear seat head restraint is locked into the upright position with a push/pull from the top of the rear seat head restraint.
 - If the rear seat head restraint locks and remains in the upright position, proceed to Step 1 and perform the inspection for a total of 5 times on each rear seat head restraint.
 - If the rear seat head restraint does NOT lock and remain in the upright seating position, replace it. Refer to *Rear Seat Head Restraint Replacement* in SI. Begin this inspection again on the second head restraint.
