Service Bulletin

Bulletin No.: PIC5608A

Subject: : Oil Canning Or Pop Noise In Rear Seat Area

Models: 2010 - 2013 Chevrolet Camaro
Coupe Models Only

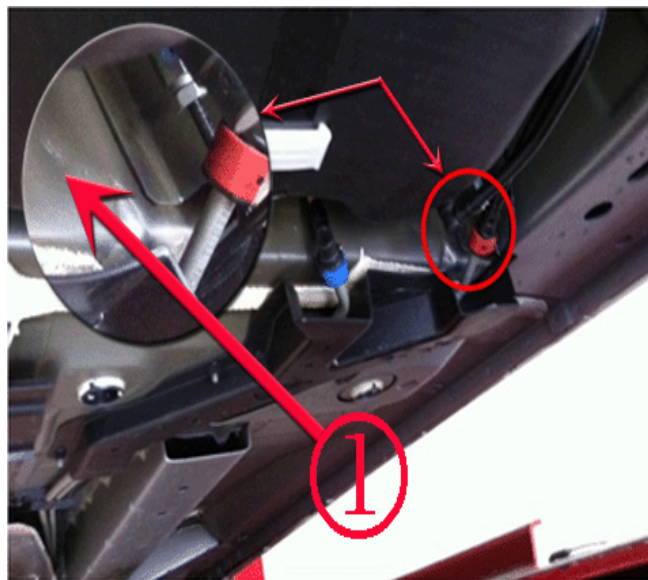
2748582

Some customers may comment on an oil-canning or popping noise coming from the rear seat foot well area while driving. This condition is most noticeable on rough uneven roads or when turning into a driveway.

This condition may be caused by "oil canning" of the sheet metal in front of the rear seat lower cushion.

1. Raise the vehicle.
2. Using a ball-peen hammer or similar tool, dimple the panel as shown below.
3. Apply a butyl patch on the panel, being sure to also cover the dimpled surface with the patch.
