Service Bulletin

Bulletin No.: PIC5718A

Subject: Instrument Panel (IP) Center Soft Insert Above Radio Center Stack Appears Deformed or Wrinkled

Models: 2012 - 2013 Chevrolet Camaro

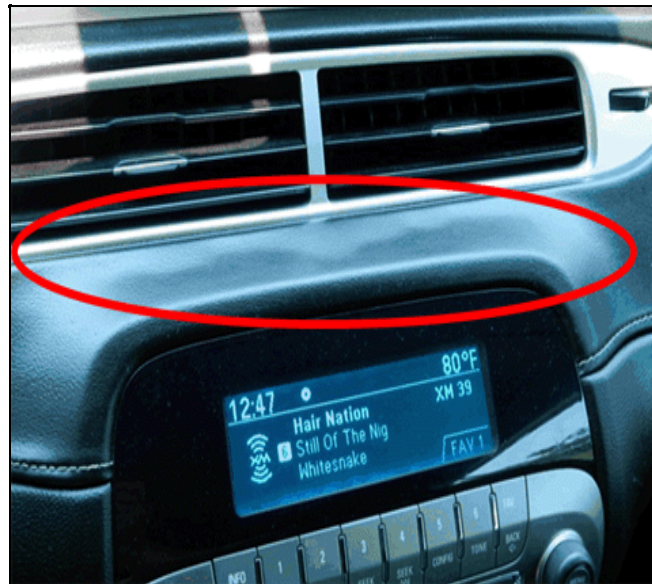
2897713

Some customers may comment that the dash pad area located directly above, or slightly to the left or right of the radio center stack appears to be deformed or wrinkled. Some customers may comment that this was not like this when the car was new. Dealers may also comment that the service replacement trim piece is similar in appearance when it had been removed from the packaging. They may also notice that after this trim piece has been replaced and exposed to direct sunlight for some time, the concern has reoccurred.

Engineering is aware of this parts issue and it is currently under investigation. Dealerships are advised NOT to replace the trim pad at this time until the concern has been resolved and new parts are available.
