Service Bulletin

PRELIMINARY INFORMATION

Subject: ABS Light and/or Service Stability Message On With DTC C0045 and/or C0050

Models: 2008-2012 Chevrolet Express 2008-2012 GMC Savana

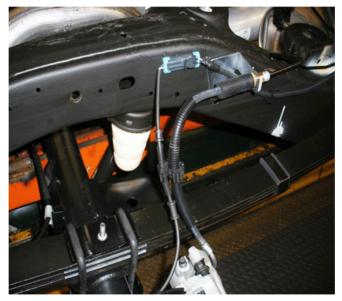
2137758

Some customers may comment of the ABS light and/or Service Stability message on, and upon inspection, a DTC C0045 and/or C0050 is found in the EBCM. These DTC's may be caused by the WSS (Wheel Speed Sensor) wires being pulled out of their terminal crimps at the WSS connector. If the WSS harness is routed incorrectly around the brake hose, it can be pulled too tight during suspension movement and cause the concern.

Inspect the wires/crimps/terminals at the suspect WSS connector and make sure they are crimped to the terminal and have not pulled loose. It is also important to check the routing of the WSS harness. The harness should NOT wrap around the brake hose. See the picture below for the correct routing of the WSS harness.
