Technical Service Bulletin

UPDATE 23F1 - SVM update and Missing Emblems (FED_EMS)

November 16, 2012. Supersedes Technical Service Bulletin Group 23 number 10-05 dated February 26, 2010 for reasons listed below.

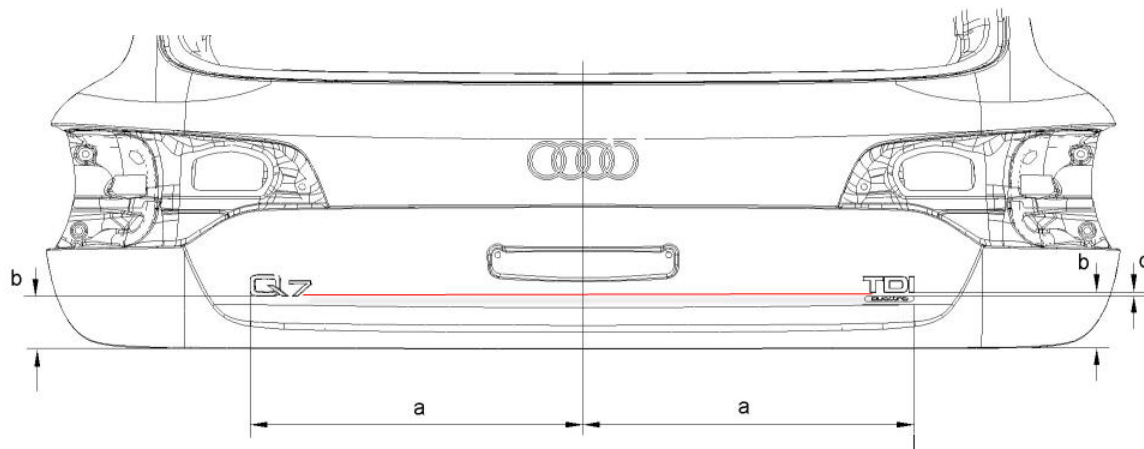
Figure 1. Alignment of “Q7” and “TDI” emblems.

1. The bottom edge of the “Q7” emblem and the bottom edge of the “TDI” emblem should be aligned with each other on the same horizontal line as indicated by the red line in Figure 1. The “quattro” emblem sits below this line.

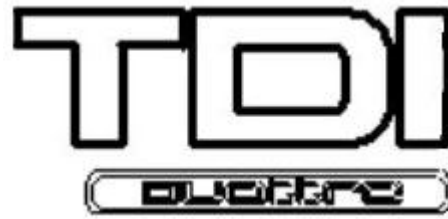
Figure 3. Right-justified emblems (extreme case shown).

i **Tip:** The “TDI” and “quattro” emblems should have the same approximate width, but if one of the emblems is slightly longer than the other, align the right edge of the emblems with respect to each other (right justify).

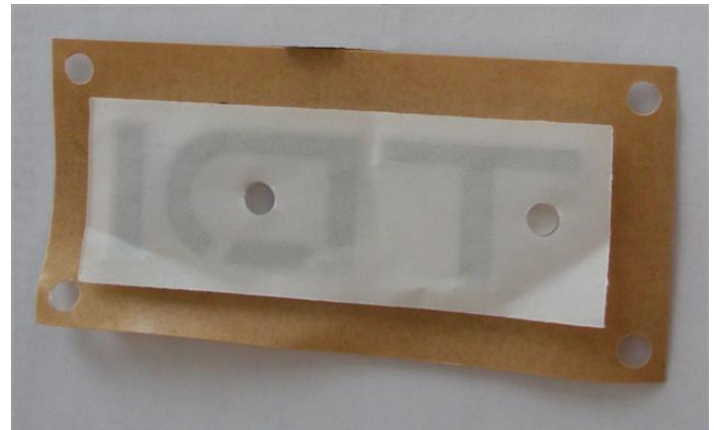
Figure 4. New TDI emblem.

3. The new “TDI” emblem comes prepared with brown adhesive paper on the front surface of the emblem to help maintain the correct spacing of the “T”, “D”, and “I” during installation.

Carefully remove the wax paper covering the adhesive on the rear of the emblem. Keep the adhesive paper on the front still intact.
