Technical Service Bulletin

01 Cam adjuster, implausible signal - V6 FSI AVS

15 12 25 2031085/1 October 10, 2012.

Model(s)	Year	VIN Range	Vehicle-Specific Equipment
A6	2010 – 2012	All	CALA Engine
A4	2009		CALB Engine
Audi Q5	2009 – 2012		CALA Engine
A5	2009		CALA Engine

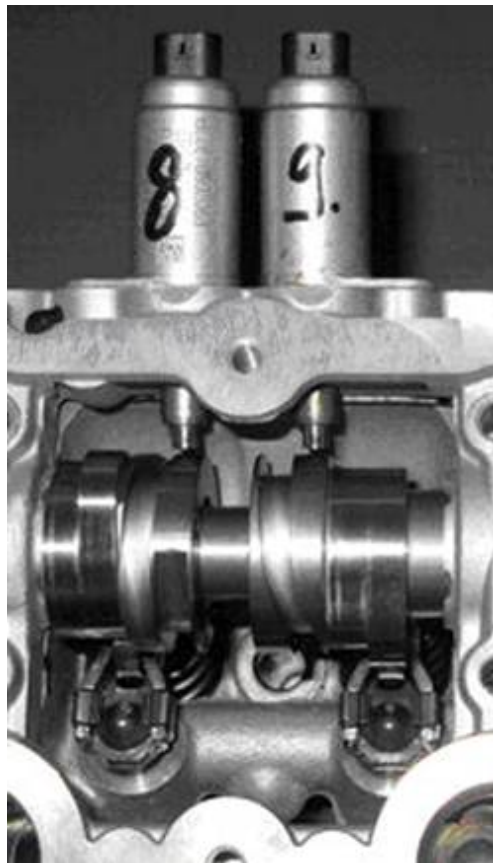
Figure 1. Adjustment unit for valve lift system.

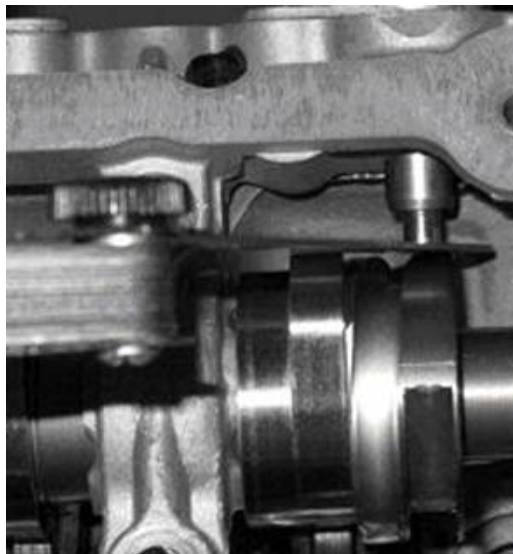
Check the distance of the pin tip of the cam actuator for valve lift system to the camshaft when it is not operated with a gauge. The measurement of the tip to the basic camshaft circle outside of the groove must be taken, see Figures 1-3 below.

Figure 2. Measurement of distance from tip of adjustment unit to camshaft with gauge.

If this measurement is 0.9mm, the actuator **06E103697J** must be installed.

The actuator **06E103697J** must only be used, if the measurement is 0.9mm or bigger.

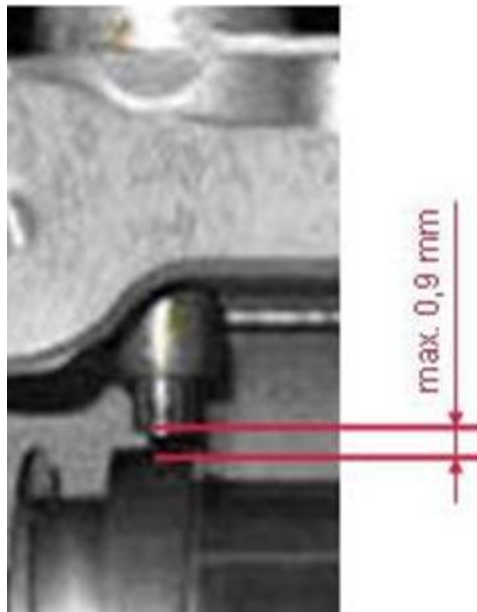
Figure 3. Distance from adjustment unit tip to camshaft – max. 0.9mm.
