Technical Service Bulletin

21 Mil on - P0299 Negative pressure deviation, turbocharger excessive wastegate play

21 12 10 2031245/1 October 25, 2012.

Model(s)	Year	VIN Range	Vehicle-Specific Equipment
A4	2009-2010	All	6 speed automatic (0B6)
A5			
A5 Cab

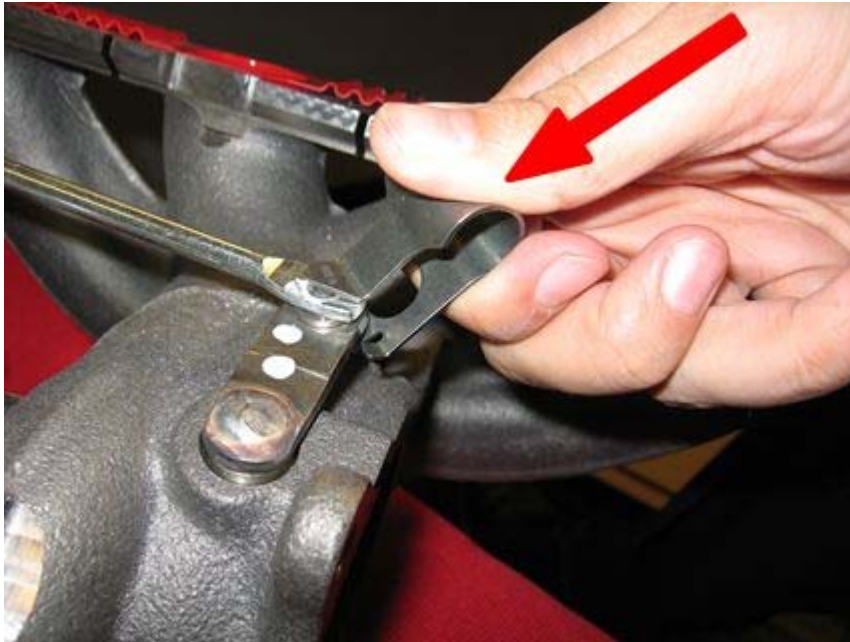
Figure 1. *Fit the clip from the side.*

- Remove turbocharger as per ELSA instructions, *Repair Manual / Engine / Engine Mechanical / 21 Turbocharger, G-Charger / Removal and Installation / Turbocharger*.
- Install clip 06J 145 220 B on a replacement turbocharger' s link plate and actuating rod joint as shown in Figure 1 +2:

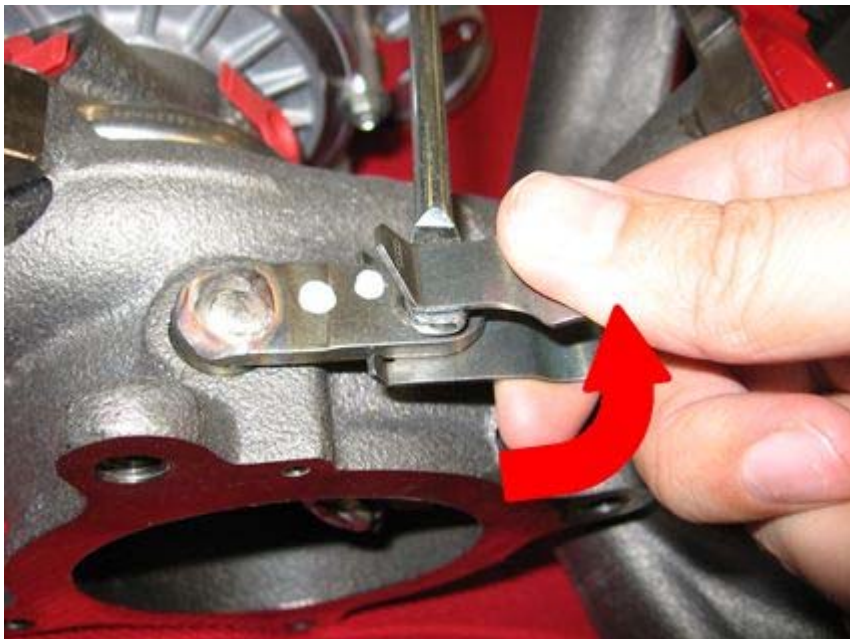
Figure 2. *Turn the clip counter clockwise till the lugs slot in.*

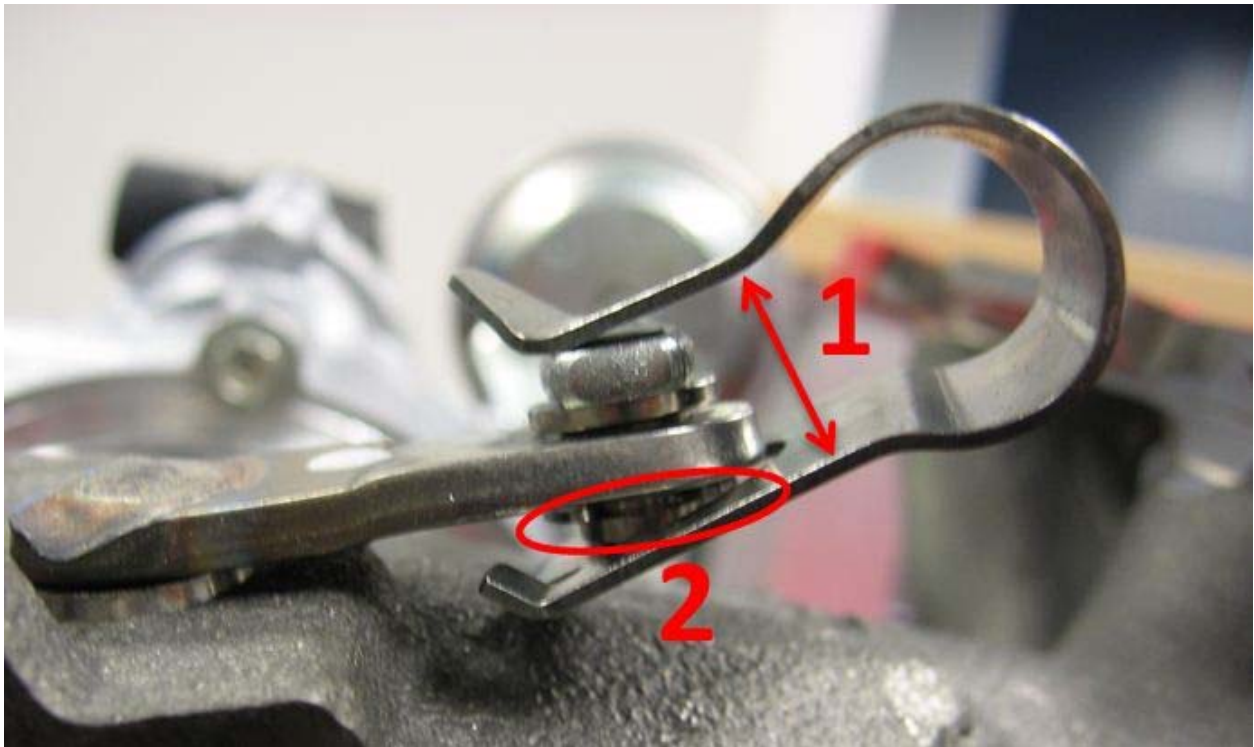
Figure 3. (1) Maximum opening of clip, (2) Position of original circlip

- The spring clip must not be overstretched. The maximum opening of the spring clip is 14 mm (Figure 3-1).

- After fitting the spring clip check the position of the original circlip (Figure 3, 2) and correct it if necessary.

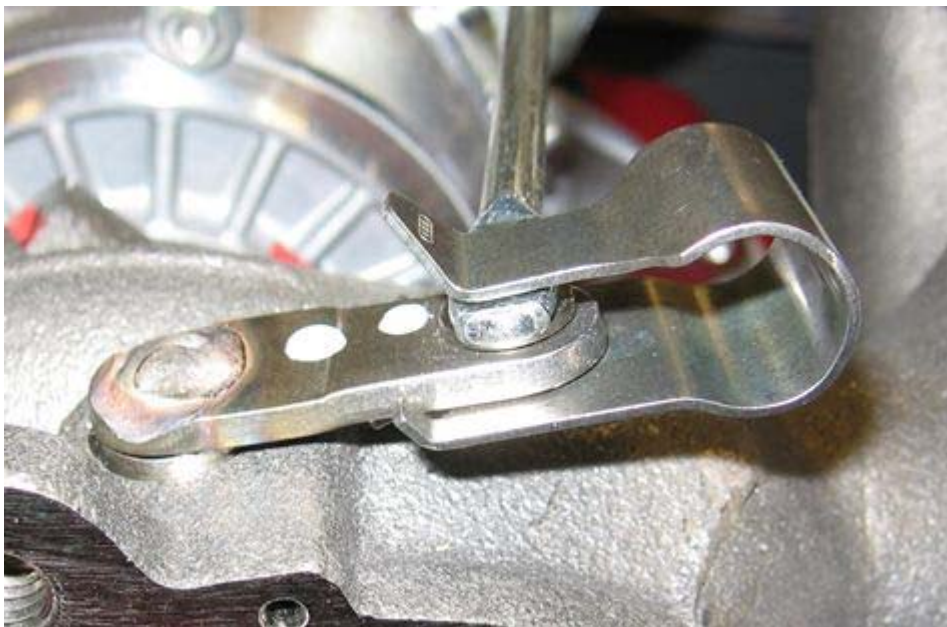
Figure 4. Correctly fitted clip.

- The spring clip must be replaced after every removal.
- After fitting the spring clip check for correct fit (Figure 4).
