Technical Service Bulletin

27 Excessive Voltage DTCs present in multiple control units

27 12 14 2031145/1 October 12, 2012.

Model(s)	Year	VIN Range	Vehicle-Specific Equipment
A4, A5, Audi Q5, Cabriolet	2009 – 2012	000001 – 999999	Not Applicable
C6 A6, D3 A8	2009 – 2010		
C7 A6, A7, D4 A8	2010 – 2011		
R8, Audi Q7	2009 – 2011

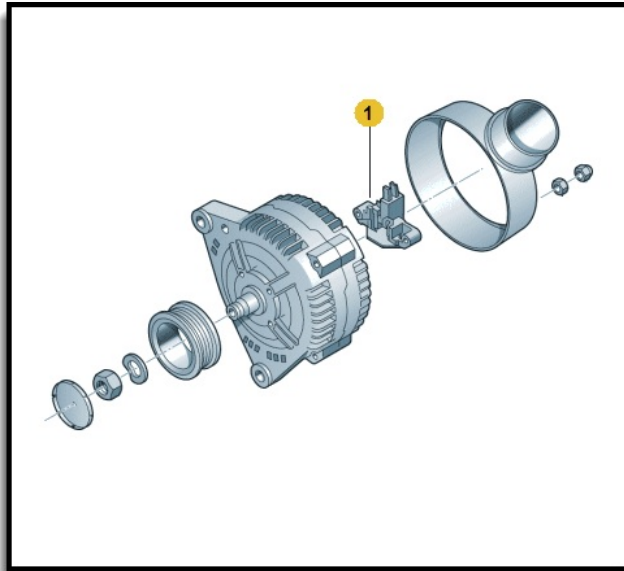
The voltage regulator on the alternator (Figure 1) can sporadically fail causing the electrical system to experience too high of voltage. As a result, the affected vehicle electronic components go in to high voltage protection and deactivate sensitive displays and indicators to prevent electrical damage. When an over voltage condition occurs the vehicle electronics and alternator are protected, **thus there is no need to replace the entire alternator assembly.**

Figure 1 Voltage Regulator (1) Mounted on the Alternator.

1. **ONLY** replace the voltage regulator and **NOT** the alternator assembly. The original alternator should function normally with the newer style voltage regulator fitted.
 - a. Different vehicles, even of the same model range and model year, can have different alternators from different vendors, i.e. Valeo, Bosch, or Hitachi. You must reference the actual part on the car and cross reference it with ETKA to determine which voltage regulator is required for the vehicle.
 - b. Replace the voltage regulator according to the ElsaWeb repair manual instructions.
Repair Manual>>Electrical System>>Electrical Equipment General Information>>27 Battery, Starter, Generator, Cruise Control>>Removal and Installation>>Voltage Regulator

1. **ONLY** replace the voltage regulator and **NOT** the alternator assembly. The original alternator should function normally with the newer style voltage regulator fitted.
