Technical Service Bulletin

37 Customer may report harsh shift concerns. No faults stored and concern is reproducible.

37 12 65 2030007/4 September 25, 2012. Supersedes Technical Service Bulletin Group 37 number 12 – 62 dated August 30, 2012 for reasons listed below.

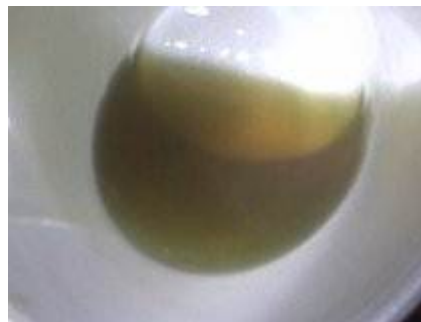
Figure 1. Sample fluid

Tip: Figure 1 is a good example of a fluid sample, 1 inch or so of fluid in the white cup held on an angle to show depth and color.
