Technical Service Bulletin

40 Clicking noise from wheel bearing

40 12 26 2024318/2 September 26, 2012. Supersedes Technical Service Bulletin Group 40 number 10 – 13 dated December 21, 2010 for reasons listed below.

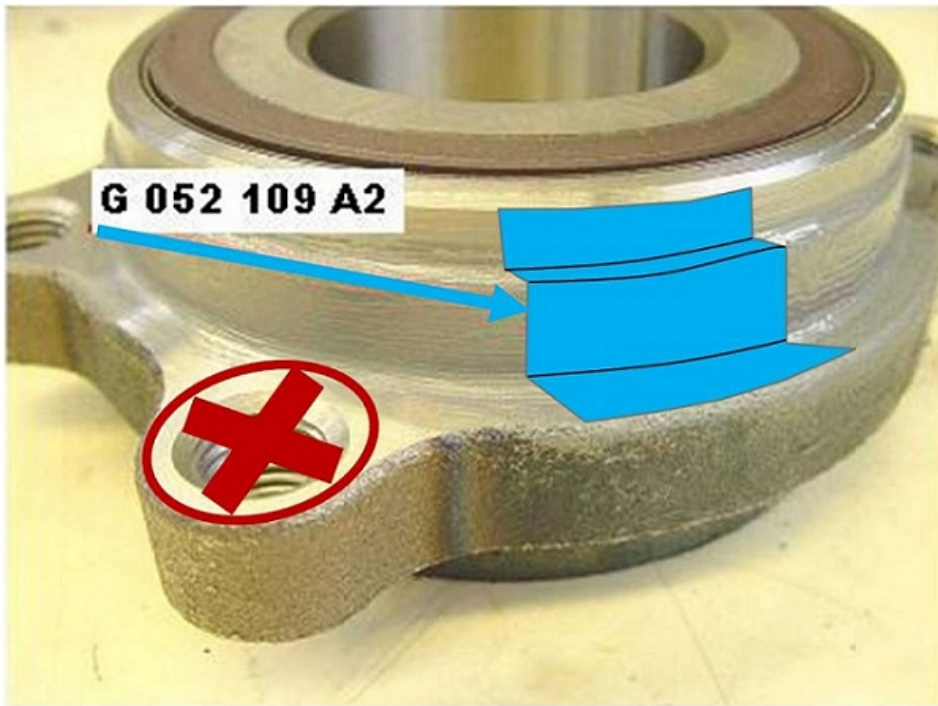
Clicking or clacking noise when maneuvering or parking.

Normal driving dynamics may cause microscopic movements between the wheel bearing and wheel bearing housing.

Figure 1. Area to apply paste.

1. Remove any corrosion and dirt from the wheel bearing housing and the wheel bearing.
2. Using a brush, apply a thin coat of paste **G 052109A2** on the wheel bearing housing as shown in Figure 1. Make sure not to apply any paste on the threads.
