Technical Service Bulletin

40 Clicking noise from wheel bearing

40 12 27 2024318/3 November 8, 2012. Supersedes Technical Service Bulletin Group 40 number 12-26 dated September 26, 2012 for reasons listed below.

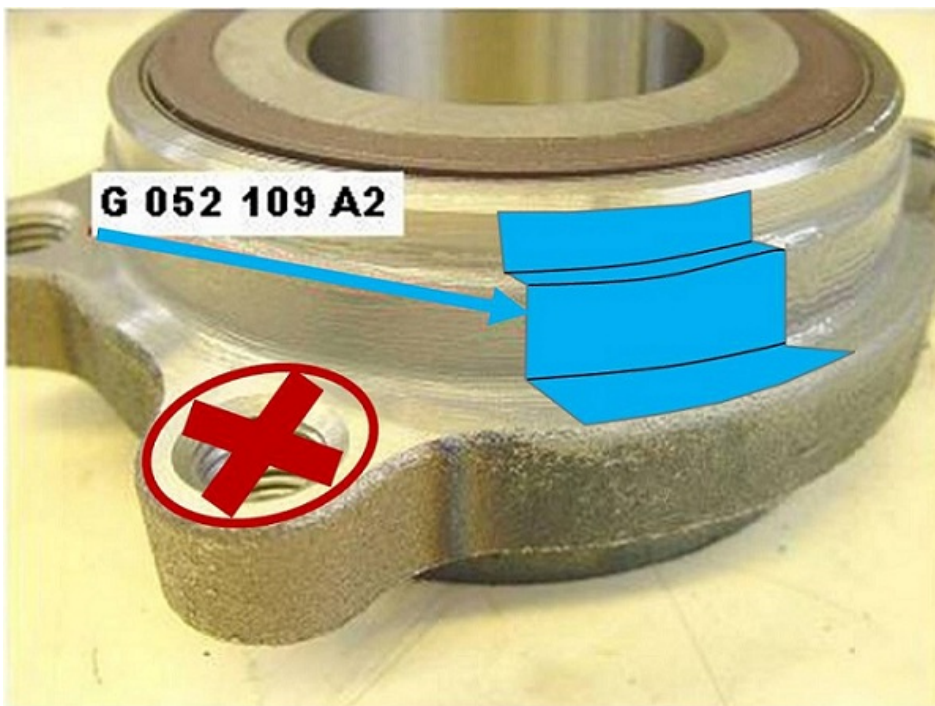
Clicking or clacking noise when maneuvering or parking.

Normal driving dynamics may cause microscopic movements between the wheel bearing and wheel bearing housing.

Figure 1. Area to apply paste.

1. Remove any corrosion and dirt from the wheel bearing housing and the wheel bearing.
2. Using a brush, apply a thin coat of paste **G 052109A2** on the wheel bearing housing as shown in Figure 1. Make sure not to apply any paste on the threads.
