Service Bulletin

Bulletin No.: PIP4885F

Subject: NQG 4WD Models With Noise, Vibration On Dry Pavement

Models: 2007-2013 Chevrolet Silverado
2007-2013 GMC Sierra
Equipped with manual shift transfer case NQG

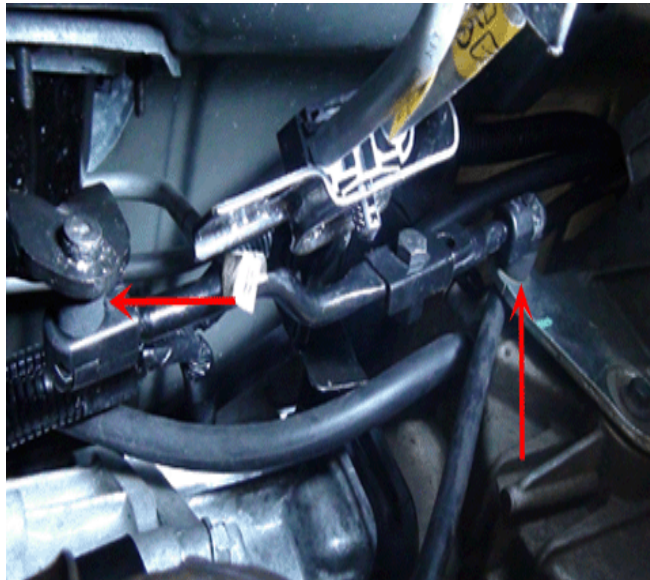
2789284

The first thing that should be done is to compare with a like vehicle. Ensure that interior content is the same i.e.: both vehicles have carpet or vinyl flooring, same model and both do or do not have plow provisions RPO VYU. Further diagnostics would include shifting the transfer case to 4WD high and then disconnecting the shift linkage from the shift lever, at one of the points shown below, and reevaluating the vehicle operation. If the noise is greatly reduced or eliminated then the shift lever is the transfer path for the noise and is an operating characteristic. No repairs are recommended for this condition.

Note: Warranty analysis on nearly every bearing that has been replaced due to customer noise complaints on NQG T-cases have been identified as no trouble found. If the noise heard while in 4wd inside the cab is eliminated by linkage removal then do not disassemble the T-case. Engineering is in the process of validating a revised shift rod to eliminate this noise and should be released 2013 time frame. Replacement of part number light duty: 15007687, heavy duty: 25910465 will not change this noise. This pi will be updated when parts become available.
