Service Bulletin

Bulletin No.: PI0672A

Subject: Wind Noise from Rear Side Door Stationary Window

Models: 2011-2013 Buick Regal

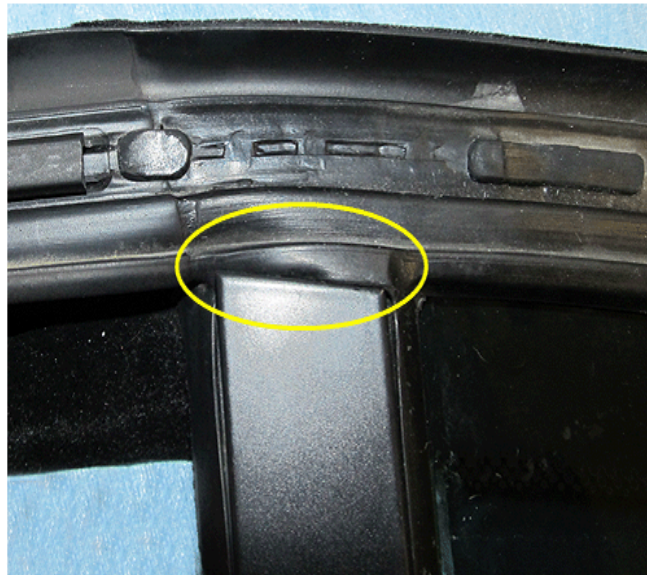
2767628

Some customers may comment on hearing a wind noise coming from the left or right rear side door stationary window.

The cause of this condition may be that the vertical channel on the stationary window assembly is loose or positioned low, not allowing the top of the channel to properly tuck under the upper seal flange. An example of this condition is shown circled in the graphic above.

Reposition the vertical channel on the stationary window assembly by following the steps below:

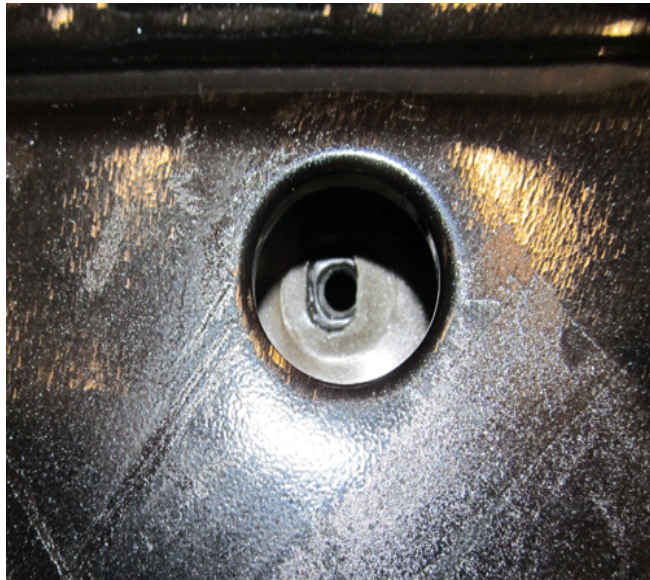
2767646

Note: The hole in the window channel bracket is slightly oblong in the vertical direction. Minor adjustment can be attained by raising/lowering the bracket position in relation to the hole in the sheet metal.
