# Service Bulletin

Bulletin No.: PI0690A

**Subject:** MIL Illuminated, DTCs P0961, P0965, P0969, P2762 and Battery Has Been Relocated

**Models:** 2010-2012 Chevrolet Express  
2010-2012 GMC Savana  
Equipped with 6L90 Automatic Transmission (RPO MYD)

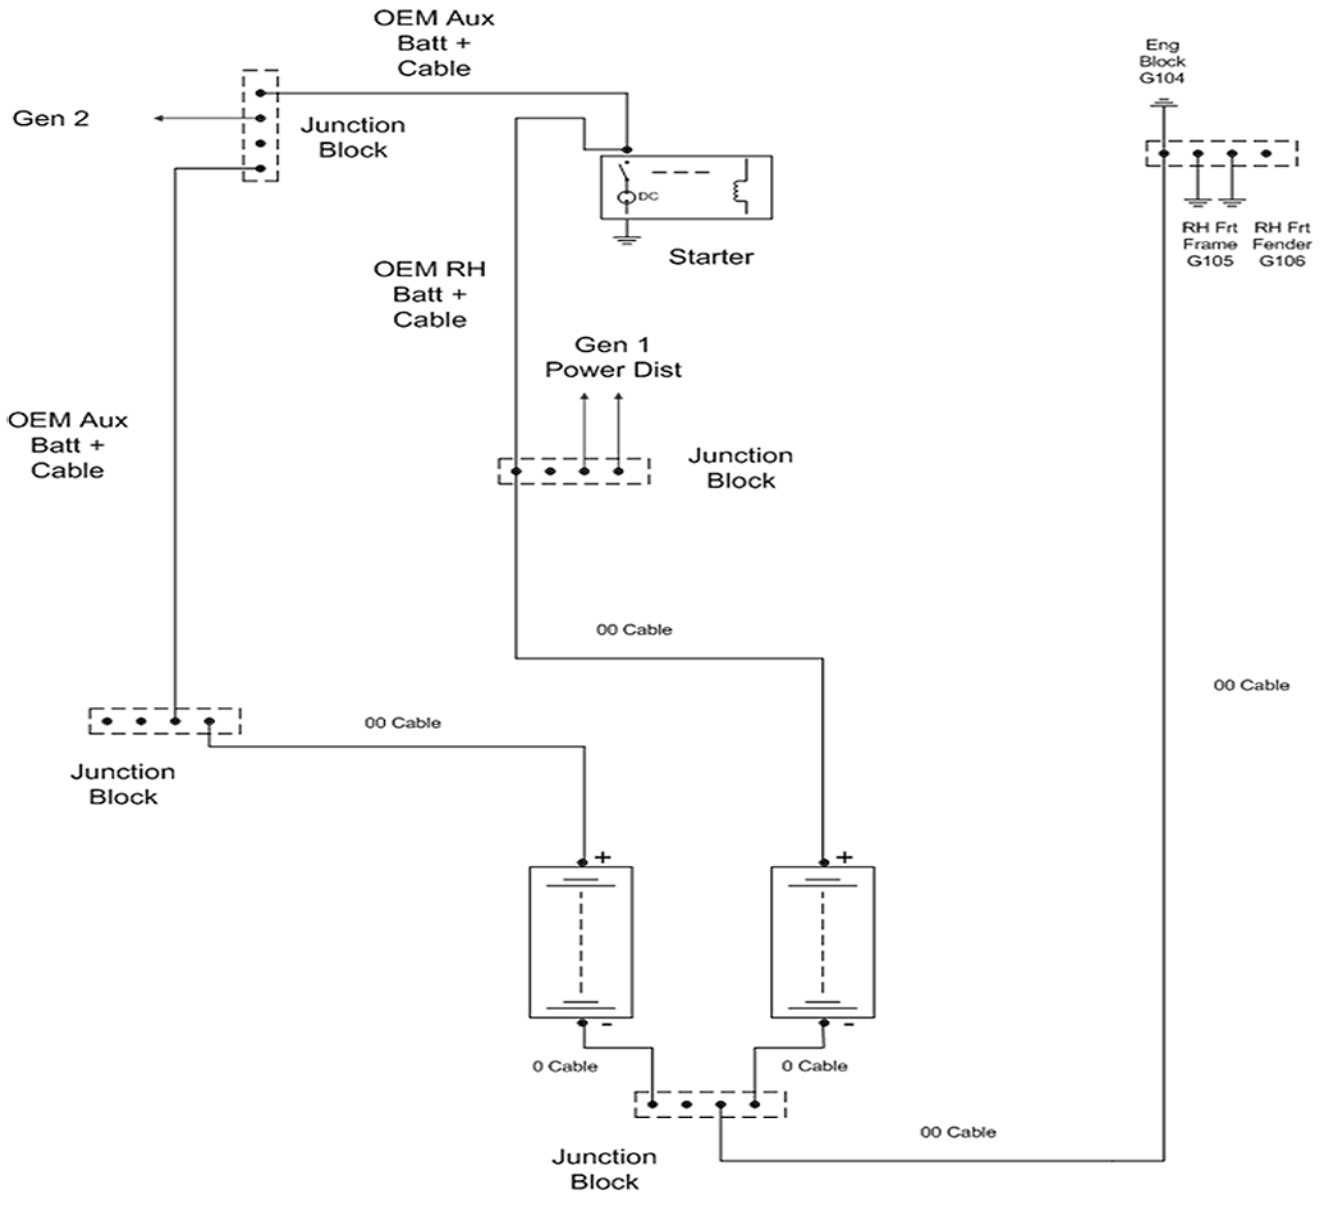
2778341

These transmission DTCs are likely the result of improper battery grounding.

Grounding cannot be done through the frame rail. The battery must be grounded directly to the engine.

1. Remove any ground connections between the battery/batteries and the frame rail.
2. Install an isolated ground stud underhood at or near the original battery location.
3. Install new, 00 Gage or larger ground cable from the remote battery/batteries to the new, isolated ground stud underhood.
4. Connect the original, underhood battery ground cable to the new isolated ground stud. Ensure that all original ground cable connections (G104, G105, G106) are secure. Or, connect new 0 Gage or larger ground cable from the new isolated ground stud to G104, G105 and G106 ground locations. Refer to SI Master Electrical Component List for the location of these ground points.
5. Ensure that G103 at the rear of the LH engine head has a clean and tight connection.
