L-SB-0033-08

Rev1

Hesitation on Acceleration

YEAR(S)	MODEL(S)	ADDITIONAL INFORMATION
2007 – 2008	LS460

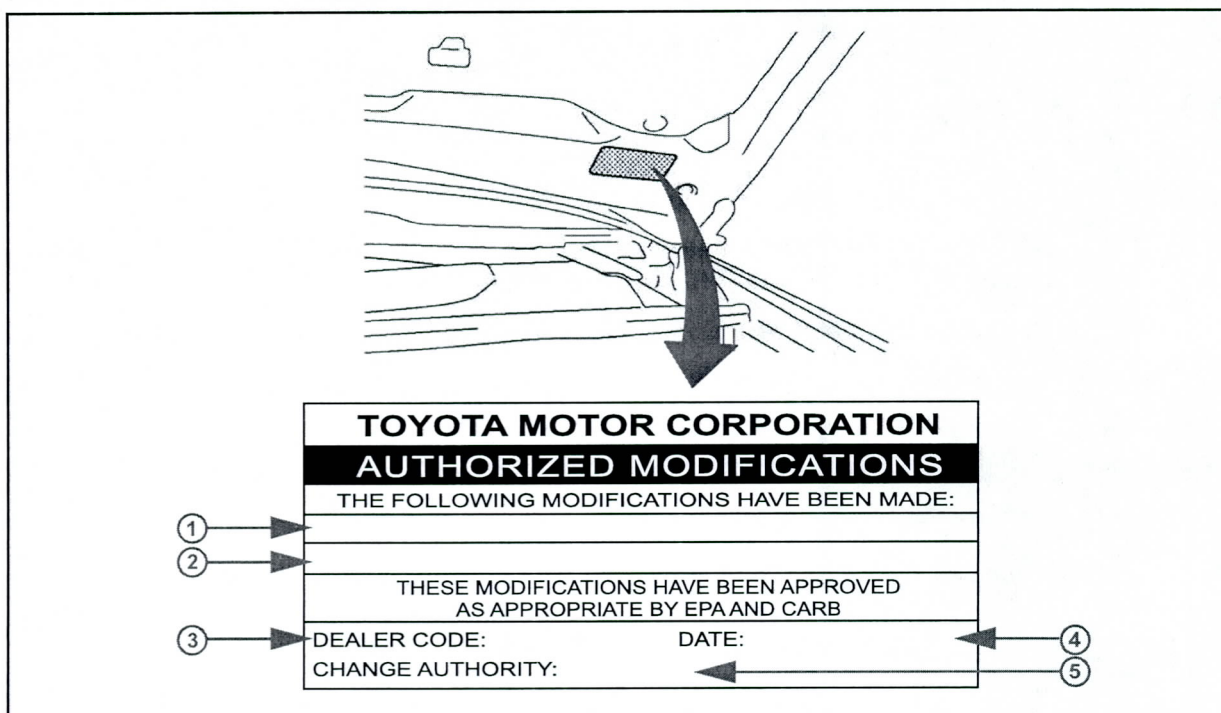
Figure 1. Location of Authorized Modifications Label on 2007 LS 460

1. Check for the Authorized Modifications Label affixed to the vehicle in the location shown in Figure 1. Confirm if the ECM (PCM) calibration has been updated. If the calibration ID listed is NOT the latest ECM (PCM) calibration — go to step 2.

3. Install the Authorized Modifications Label.
 - A. Using a permanent marker, enter the following information on the label:
 - ECM part number [Refer to the **Parts Information** section for the **CURRENT PART NUMBER**]
 - Calibration ID(s) [Refer to the **Calibration Identification Chart** for the **NEW CALIBRATION ID**]
 - Dealer Code
 - Repair Date
 - Change Authority [**This TSIB number**]
 - B. Affix the Authorized Modifications Label to the vehicle at the location shown in Figure 1. The Authorized Modifications Label is available through the MDC, P/N 00451-00001-LBL.
4. Start the engine and warm it up to normal operating temperature before test driving.
5. Test drive the vehicle to confirm that the hesitation is NO longer present.
