## Retailer Technical Journal 20235 Water in Tail Lamp, Bulb Socket Seal

Date 07-30-2009

Volvo Cars of North America, LLC  
Technical Engineering

# SB-10030933-7510

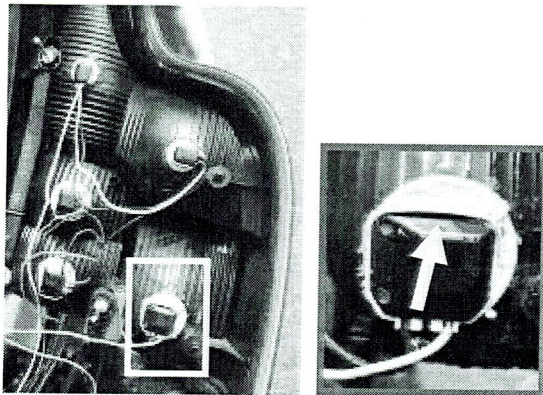
Remove the tail lamp and inspect all the bulb holders to ensure that replacing the harness alone will repair the leak.

Note the open seam on one of the bulb holders. This may be the source of the water intrusion.

If the water is **NOT** entering from the outside, replace the harness only. See the following for the harness replacement method.
