**Title** Water in tail lamp - bulb socket seal  
**Ref No** US20235.1.3 en-GB  
**Issuer** -  
**Partner** 3 US 7510 Volvo Cars North America  
**Func Group** 3539  
**Func Desc** miscellaneous

# Retailer Technical Journal 20235

## Water in Tail Lamp, Bulb Socket Seal

Model	Type	Model year	Chassis range
XC90	275	2007 - 2009	328000 - 496962

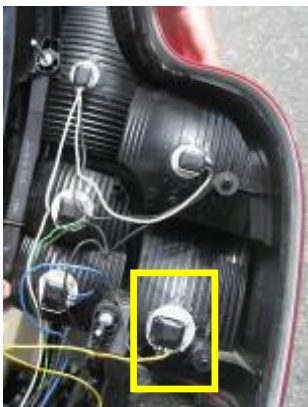
Remove the tail lamp and inspect the bulb holder to ensure the harness alone will repair.

Note the open seam of the bulb holder this is the source of the water intrusion.
