SUBJECT

Power Reduction, FC 2A82 Intake VANOS and/or FC 2A87 Exhaust VANOS Camshaft Faults are Stored in DME

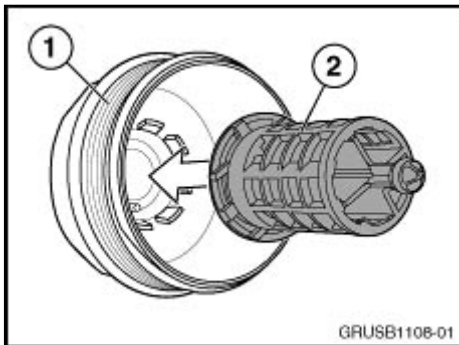
2. **NEW** The oil filter cap insert may have been inadvertently removed during the vehicle's last oil service. If this insert is not installed, it will result in non-filtered engine oil being supplied to the engine, thus possibly clogging or damaging the VANOS solenoids.

NEW If the oil filter cap insert is found to be missing, the entire oil filter housing cap must be replaced (refer to the EPC).

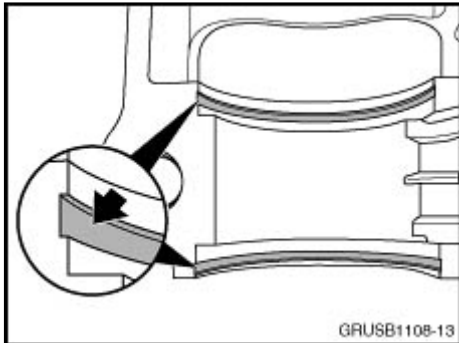
Note the deep grooves worn into the camshaft bearing ledge by the camshaft hook ring seals. The camshaft bearing ledge is worn.

If the oil filter cap insert is found to be missing, then the entire oil filter housing cap must be replaced (refer to the EPC). If excessive wear to the camshaft bearing ledge is found, it is only necessary to replace the camshaft hook ring seals and the affected camshaft bearing ledge.

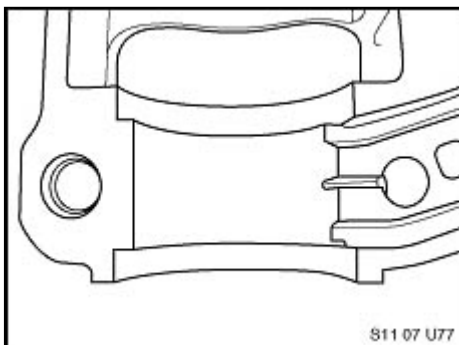
Acceptable camshaft bearing ledge – minor gray wear marks from the rotation of the camshaft are normal. If deep grooves are not apparent, the camshaft bearing ledge is acceptable and should not be replaced.
