SB-10032791-3705

SERVICE BULLETIN

CLICKING NOISE FROM REAR AXLES DURING TAKE-OFF/ACCELERATION

APPLIED VEHICLES: 2004-2010 Armada (TA60)

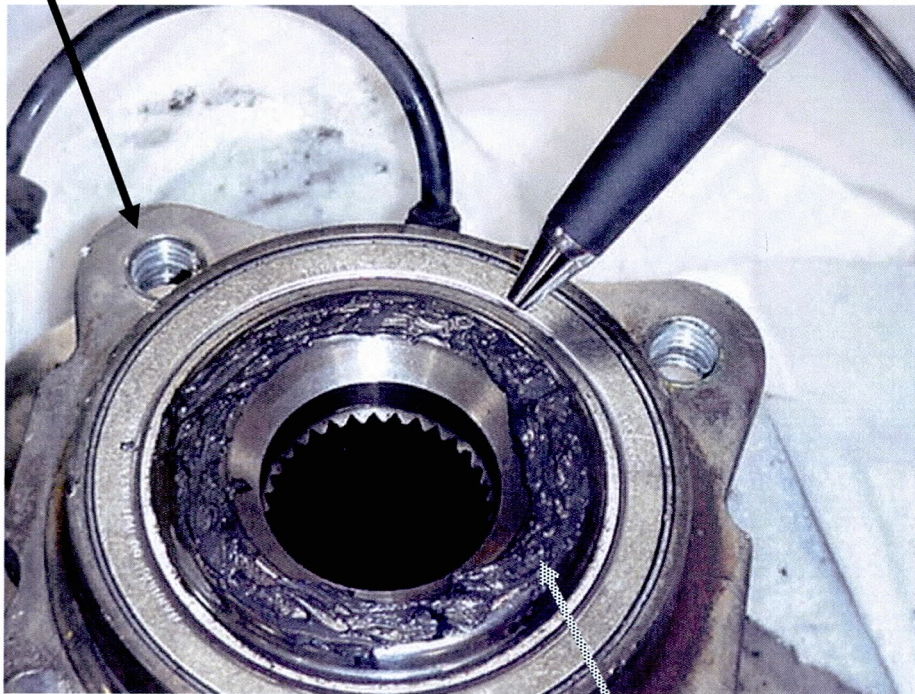
Figure 1

Rear Axle Hub

Molykote M77 Grease

1. Remove both Rear Axle Hubs. Refer to the **RAX** section of the applicable Service Manual for the removal procedure.
2. Clean all dirt and foreign material from both axle shaft-to-bearing mating surfaces.
3. Apply a minimum of 1.0g of Molykote M77 Grease (P/N 44003-7S000CM) in an even coating to the bearing surface where it contacts the rear axle (see Figure 1).
4. Re-install the Rear Axle Hubs per the Service Manual instructions.
 - Use new Bolts when re-installing Rear Axle Hubs. See Parts Information.
5. Tighten the Axle Nuts to the **new** specification of:
 - 206 – 216 N•m (21 – 22 kg-m, **152 - 160 ft-lb**)
6. Test drive the vehicle to confirm the incident is resolved.
