SERVICE BULLETIN

Classification:	Reference:	Date:
RA04-002d	NTB04-113d	October 6, 2011

2004-2012 ARMADA; CLICKING NOISE FROM REAR AXLES DURING TAKE-OFF/ACCELERATION

APPLIED VEHICLE: 2004-2012 Armada (TA60)

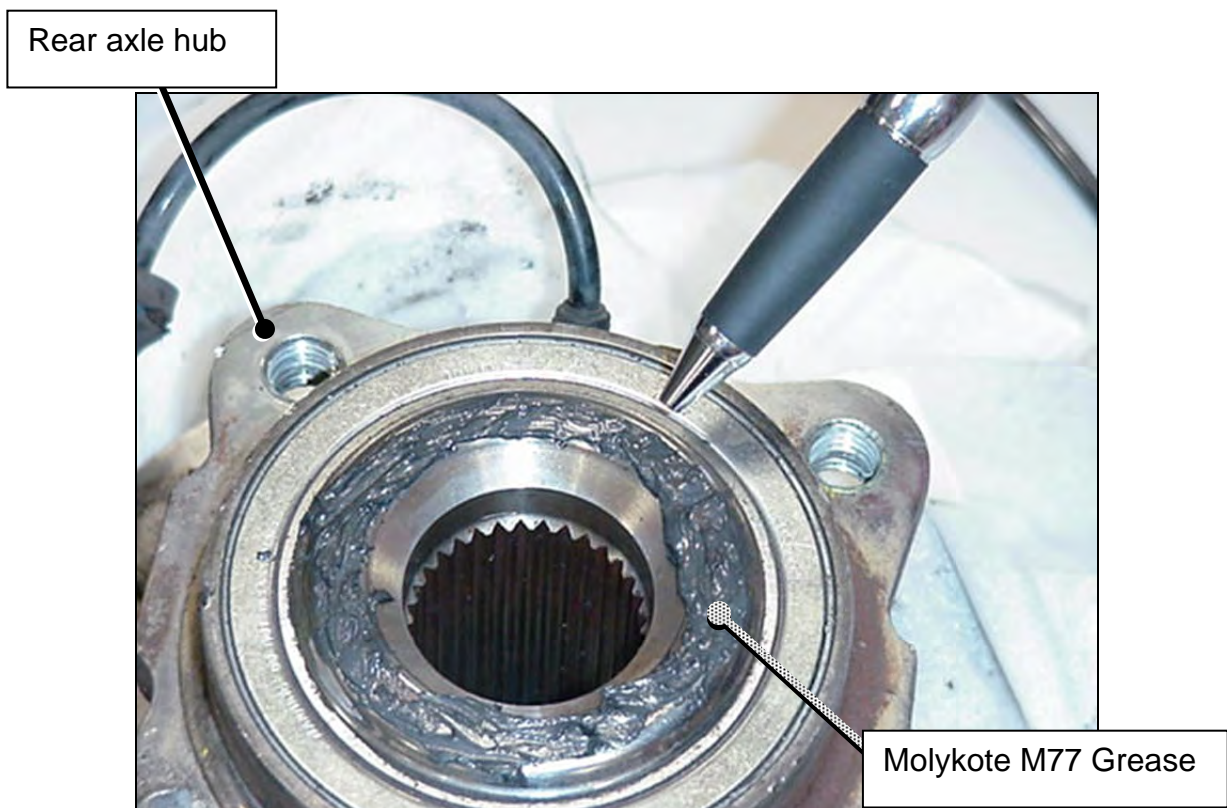
Figure 1 (Hub removal not necessary)

An applied vehicle has a “clicking” noise coming from the rear axles during take-off / acceleration.

5. Slide the axle inward to expose the back side of the hub.
6. Clean all dirt and foreign material from both axle shaft-to-bearing mating surfaces.
7. Apply a minimum of 1.0g of Molykote M77 Grease (P/N 44003-7S000) in an even coating to the bearing surface where it contacts the rear axle (see Figure 1).

NOTE: Figure 1 shows the hub removed. This is done for easier viewing only. It is not necessary to remove the hub.
