Service Action Circular

Code: **97R7**

**Subject: 2006-2009 Passat and Passat Wagon 3.6L Vehicles and
2009 CC/Passat CC 3.6L Vehicles
Inspect, and If Necessary, Replace Positive Battery Cable**

April 2010

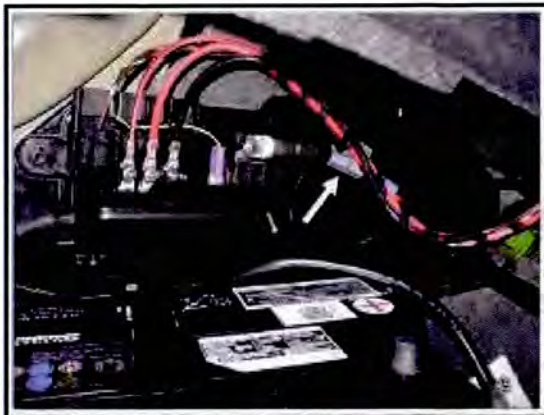
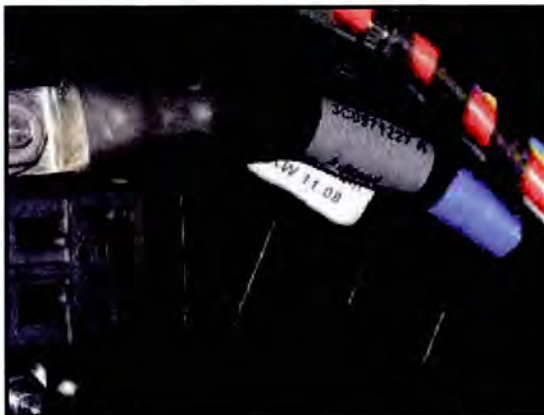
It is important to check the part number of the existing cable to determine which replacement cable is needed

- Unclip battery service cover on side trim
- ⇐ Check part number on the sticker -arrow-
- If part number is 3C0 971 227, then part number 3C0 971 227C must be installed
 - If part number is 3C0 971 227A, then part number 3C0 971 227B must be installed
 - If correct part number is currently installed, positive battery cable is not one that needs to be replaced, **WORK IS COMPLETE; otherwise, continue to Section B**
