Service Action Circular

Code: 97R7

**Subject: 2006-2009 Passat and Passat Wagon 3.6L Vehicles and
2009 CC/Passat CC 3.6L Vehicles
Inspect, and If Necessary, Replace Positive Battery Cable**

Vehicles affected by this action may have a positive battery cable that may corrode and, in rare cases, break. If this happens, the power supply may be disrupted and the vehicle cannot be started. This action does not apply if the 97P4/Y5 RVU has already been done.

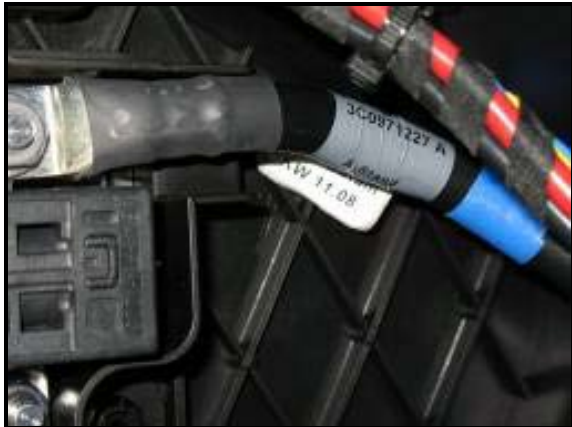
It is important to check the part number of the existing cable to determine which replacement cable is needed

- Unclip battery service cover on side trim
- ⇐ Check part number on the sticker -arrow-
- If part number is 3C0 971 227, then part number 3C0 971 227C must be installed
- If part number is 3C0 971 227A, then part number 3C0 971 227B must be installed
- If correct part number is currently installed, positive battery cable is not one that needs to be replaced, **WORK IS COMPLETE; otherwise, continue to Section B**
