Bulletin No.: PIT4648B

Subject: ABS Light and/or Service Stability Message On With DTC C0045 and/or C0050

Models: 2008-2010 Chevrolet Express
2008-2010 GMC Savana

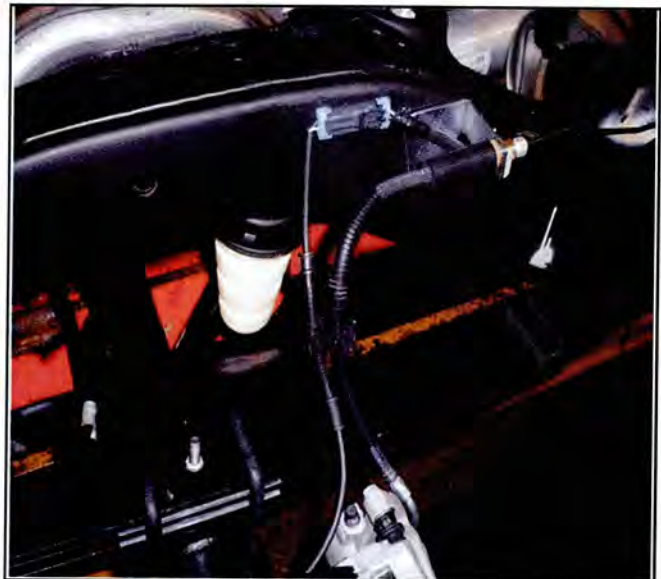
2137758

Some customers may comment of ABS light and/or Service Stability message on and upon inspection, a DTC C0045 and/or C0050 is found in the EBTCM. This code may be caused by a wire pulling out of the crimp on a terminal at the X413 or X414 connector. This concern can happen if the wire harness is pulled too tight during suspension movement. This can happen if the Wheel Speed Sensor (WSS) harness is routed incorrectly around the brake hose that connects to the caliper.

See the picture Above for the correct routing of the Wheel Speed Sensor (WSS) harness.

Check the wires at the X413 and/or X414 connector, and make sure they are crimped to the terminal and have not pulled loose. It is also important to check the routing of the Wheel Speed Sensor (WSS) harness. The harness should NOT wrap around the brake hose.
