SI M11 02 07
EngineMay 2012
Technical Service

SUBJECT**Rattle Noise from Engine****MODEL**

R55 Cooper S with N14 engine

R56 Cooper S with N14 engine

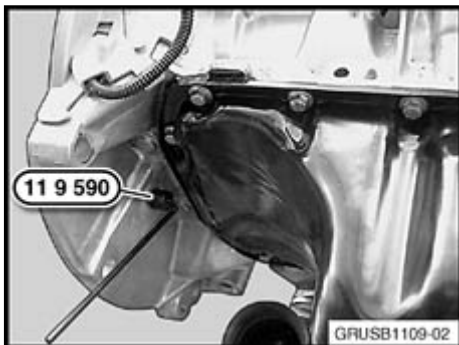
6. Remove the right-hand wheel arch trim to access the crankshaft central bolt.
7. **NEW** Disconnect the battery and remove the ignition coils and the spark plugs. Turn the engine in the clockwise direction by hand to move the flywheel to approximately 90° before TDC. Rotating the engine counterclockwise may cause an incorrect measurement.

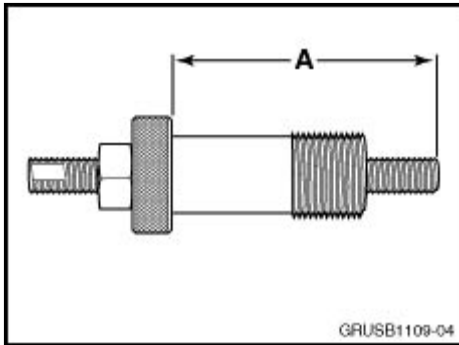
11. **NEW** Remove the chain tensioner Special Tool 11 9 340 from the engine, with the lock nut still tight. Measure the distance (A), as described in the illustration.

12. **NEW** If distance (A) is less than 68mm (and the noise can be reproduced only between 1,600-1,800 rpm), only replace the chain tensioner with P/N 11 31 7 607 551 and substitute the seal ring supplied with the new chain tensioner with improved seal ring P/N 11 31 7 631 972 (refer to parts list A).

13. **NEW** If distance (A) is 68mm or greater (and the noise is reproducible both at 1,600-1,800 rpm range as well as at idle speed when cold), replace the following components in the list below (refer to parts list B).
- Guide rail
 - Tensioner rail
 - Sliding rail
 - Sprocket on the crankshaft
 - Bearing bolts for the tensioner and guide rails
