SB-10037065-7220

SI M11 02 07
EngineSeptember 2012
Technical Service

SUBJECT**Rattle Noise from Engine****MODEL**

R55 Cooper S with N14 engine

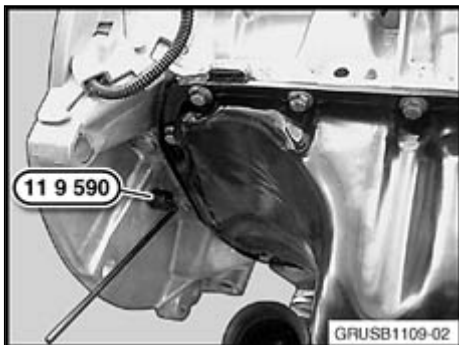
6. Remove the right-hand wheel arch trim to access the crankshaft central bolt.
7. Disconnect the battery and remove the ignition coils and the spark plugs. Turn the engine in the clockwise direction by hand to move the flywheel to approximately 90° before TDC. Rotating the engine counterclockwise may cause an incorrect measurement.

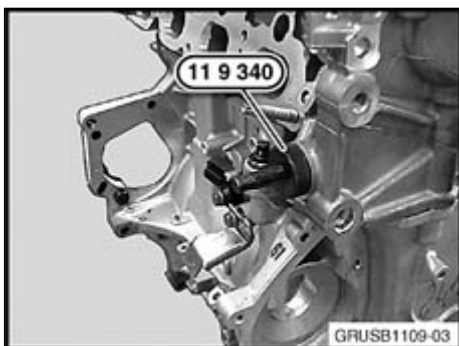
9. Remove the chain tensioner and collect the residual oil with a shop towel.

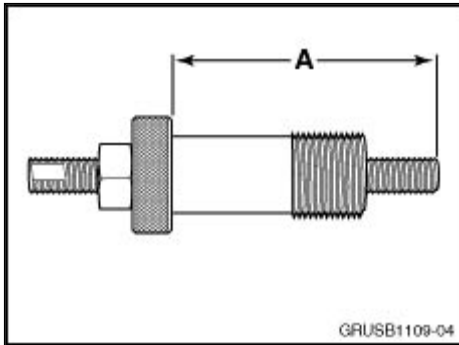
11. Remove the chain tensioner Special Tool 11 9 340 from the engine, with the lock nut still tight. Measure the distance (A), as described in the illustration.

12. **NEW** If distance A is less than 72 mm (and the noise can only be reproduced between 1,600-1,800 rpm), only replace the chain tensioner with P/N 11 31 7 607 551.

13. **NEW** If distance A is 72 mm or greater (and the noise is reproducible both at the 1,600-1,800 rpm range as well as at idle speed when cold), replace the components in the list below (refer to parts list B):
- Guide rail
 - Tensioner rail
 - Sliding rail
 - Sprocket on the crankshaft
 - Bearing bolts for the tensioner and guide rails
