Bulletin No.: PIC5327A

Subject: Service Engine Soon light on

Models: 2010-2011 Buick LaCrosse

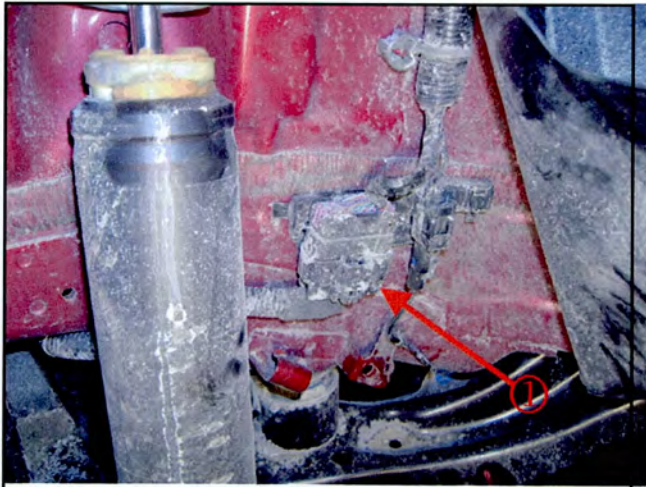
2394690

Further investigation may reveal a possible corrosion at Connector X403. (behind the right rear wheel well liner)

Remove the wheel well liner, inspect for corrosion at connector and repair/replace as needed. Once repairs have been made to the connector, pack connection with die-electric grease.
