# Service Bulletin

Bulletin No.: PIC5327C

**Subject:** Service Engine Soon Light On

**Models:** 2010 - 2012 Buick LaCrosse  
2011 - 2012 Buick Regal

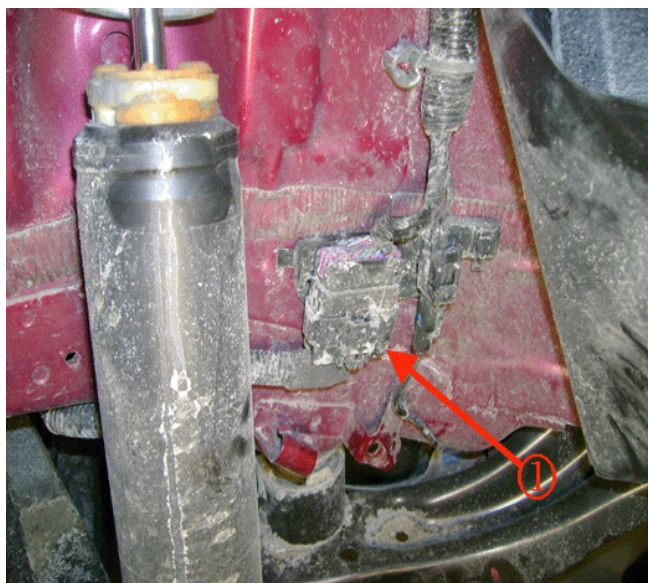
2394690

Further investigation may reveal a possible corrosion at Connector X403 (LaCrosse) or X350 (Regal).

Remove the right rear wheel well liner, inspect for corrosion at connector and repair/replace as needed. Once repairs have been made to the connector, pack connection with die-electric grease.
