# Dealer Service Bulletin

NO.: 7SB011-11-01A

**AFFECTED:** 2011 Winnebago Adventurer, Journey and Tour and Itasca Suncruiser, Meridian and Ellipse Models with a Power Gear Slideout Travel Lock

**SUBJECT:** Power Gear – Field Repair for Binding Slideout Travel Lock Motor

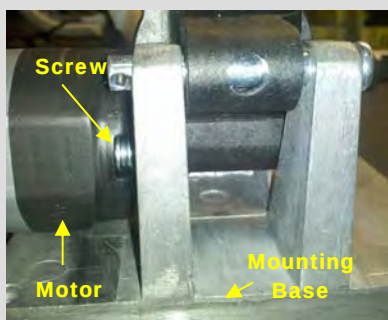
Figure 1

This tip sheet addresses an issue with the Kwikkee room lock mechanism. A tolerance issue between a SCREW on the MOTOR and the motor MOUNTING BASE can cause the MOTOR not to move back and forth or "float" (**FIGURE 1**). This can cause the room lock not to retract or bind when retracting. This lack of floating can cause the MOTOR SHAFT to bind on the ALUMINUM BASE HOUSING (**FIGURE 2**). There are two remedies for this, and they are outlined in this document.
