PRELIMINARY INFORMATION

Subject: Intermittent Engine Hesitation or Flutter without DTC (Inspect and Correct Intake Camshaft Position (CMP) Sensor Bank 1 Connector Terminals for Intermittent Conditions or Poor Connections)

Models: 2007-2011 Buick Enclave
2010-2011 Buick LaCrosse
2004-2011 Cadillac CTS, SRX, STS
2008-2011 Chevrolet Equinox
2009-2011 Chevrolet Malibu, Traverse
2010-2011 Chevrolet Camaro
2007-2011 GMC Acadia
2010-2011 GMC Terrain
2007-2009 Pontiac G6
2008-2009 Pontiac G8, Torrent
2007-2009 Saturn OUTLOOK
2008-2010 Saturn VUE
Equipped with 6 Cylinder Engine RPO LF1, LLT, LY7, LAU, LP1 or LP9

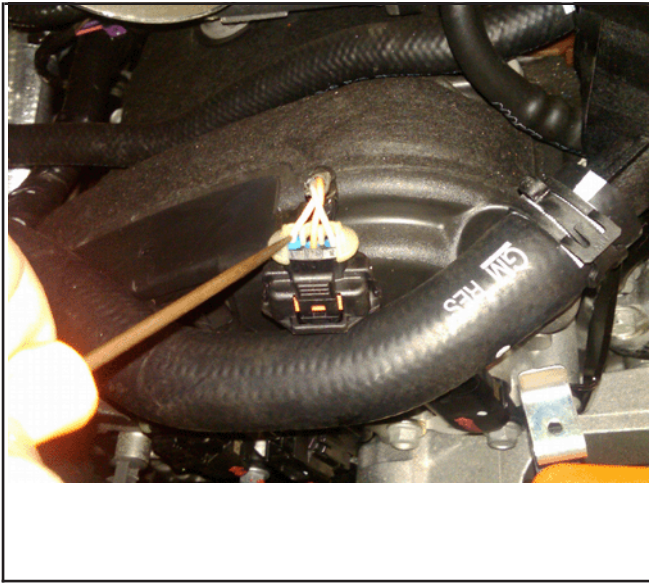
2429201

Note: Perform this visual inspection BEFORE disconnecting the intake CMP sensor bank 1 harness connector.

4. Visually inspect the CMP sensor harness connector for backed-out terminals as shown. Any of these circuits can contribute to this condition. For the component location, refer to Camshaft Position Sensor Replacement - Bank 1 (Right Side) Intake in SI.
 - If any intermittent conditions or poor connections are found, repair as needed. Refer to Connector Repairs and Wiring Repairs in SI.
5. Disconnect the CMP sensor harness connector.

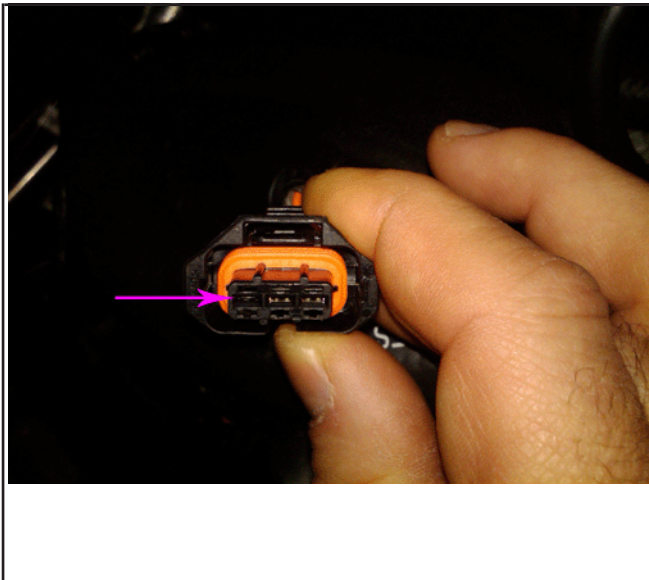
2429345

6. Visually inspect the CMP sensor harness connector for backed-out terminals as shown. Any of these circuits can contribute to this condition.
 - If any intermittent conditions or poor connections are found, repair as needed. Refer to Connector Repairs and Wiring Repairs in SI.
 - If intermittent conditions or poor connections are not found, proceed to Step 7.
7. Verify the torque of the CMP sensor bolt.
