## PRELIMINARY INFORMATION

**Subject:** Intermittent Engine Hesitation or Flutter without DTC (Inspect and Correct Camshaft Position Sensor - Bank 1 Exhaust or Camshaft Position Sensor - Bank 1 Intake Harness Connector Terminals for Intermittent Conditions and Poor Connections)

**Models:** 2008-2011 Buick Enclave  
2010-2011 Buick LaCrosse  
2004-2011 Cadillac CTS, SRX  
2006-2011 Cadillac STS  
2008-2011 Chevrolet Equinox  
2009-2011 Chevrolet Malibu, Traverse  
2010-2011 Chevrolet Camaro  
2007-2011 GMC Acadia  
2010-2011 GMC Terrain  
2007-2009 Pontiac G6  
2008-2009 Pontiac G8, Torrent  
2008-2009 Saturn AURA  
2007-2010 Saturn OUTLOOK  
2008-2010 Saturn VUE  
Equipped with 6 Cylinder Engine RPO LAU, LF1, LFW, LLT, LP1 or LY7

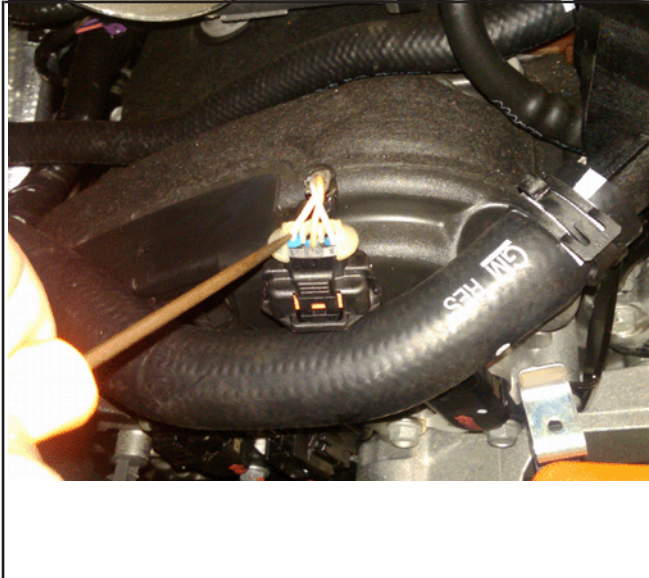
2429201

5. Visually inspect the camshaft position sensor harness connector for backed-out terminals as shown. Any of these circuits can contribute to this condition. Refer to Testing for Intermittent Conditions and Poor connections in SI.
  - If intermittent conditions or poor connections are found, repair as needed. Refer to SI. After completing the repair, proceed to Step 6.
  - If intermittent conditions or poor connections are not found, proceed to Step 6.
6. Disconnect the camshaft position sensor harness connector.

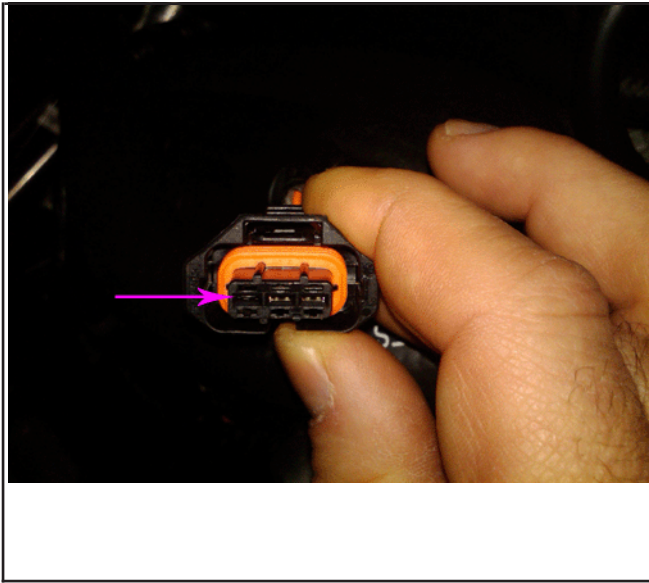
2429345

7. Visually inspect the camshaft position sensor harness connector for damaged or backed-out terminals as shown. Any of these circuits can contribute to this condition. Refer to Testing for Intermittent Conditions and Poor connections in SI.
  - If intermittent conditions or poor connections are found, repair as needed. Refer to SI. After completing the repair, proceed to Step 8.
  - If intermittent conditions or poor connections are not found, proceed to Step 8.
8. Remove the camshaft position sensor. Refer to SI.
9. Inspect for any foreign material, such as metal shavings in the magnet area of the camshaft position sensor and on the reluctor wheel.
  - If any contamination is found, clean or replace the camshaft position sensor as needed.
10. Install the camshaft position sensor.

**Tighten**  
Tighten the bolt to 10 N·m (89 lb in).
11. Connect the camshaft position sensor harness connector.
12. Clear any DTCs that may be present.
13. Perform the diagnostic repair verification after completing this procedure. Refer to Diagnostic Repair Verification in SI.
