Service Bulletin

SPECIAL COVERAGE

SUBJECT: Special Coverage Adjustment – Heating, Ventilation, and Air Conditioning Blower Not Fully Functional or Inoperative

MODELS: 2003-2006 Chevrolet Avalanche, Suburban Tahoe
2003-2007 Chevrolet Silverado
2003-2006 GMC Yukon, Yukon XL
2003-2007 GMC Sierra
Equipped with Manual HVAC (CJ3) or Heavy Duty Heater (C42)

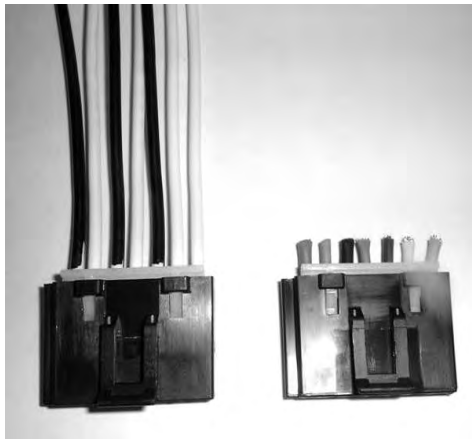
1709080

4. Remove the tape from the wiring harness to expose the wiring.

5. Cut the wires back far enough from the connector to eliminate any melted insulation on the wire.

Note: Use the old connector as a map for splicing the wires for the new connector. Be sure to use the correct crimping tool from the terminal repair kit J 38125. Use only Duraseal splice sleeves. Other splice sleeves may not protect the splice from moisture or provide a good electrical connection.
