**SB-10039766-3182**

SI B12 12 11  
Engine Electrical Systems

**Service Action: Program Control Units (EME)**

F04 ActiveHybrid 7 with the N63 engine produced from 7/23/2009 to 2/28/2011

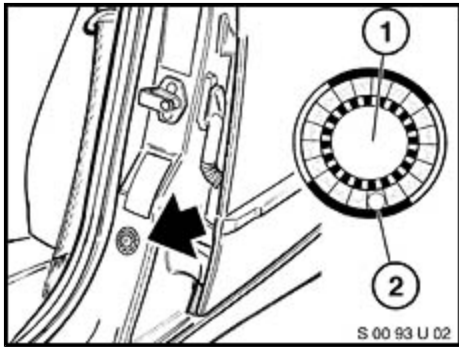
**593.** After the vehicle has been checked and/or corrected, obtain a label (SD 92-380) and:

- A. Emboss your BMW center warranty number in the middle of the label (1);
- B. Punch out code number **593** (2), printed on the label; and
- C. Affix the label to the B-pillar as shown.

If the vehicle already has a label from a previous Service Action/Recall Campaign, affix the new label next to the old one. Do not affix one label on top of another one, because a number from an underlying label could appear in the punched-out hole of the new label.
