Applies To: **2011 CR-V** – From VIN 5J6RE3...BL025265 thru 5J6RE3...BL025953  
– From VIN 5J6RE4...BL050299 thru 5J6RE4...BL051818

**May 4, 2011**

## Product Update: Water Leak In the Left Rear Wheelwell

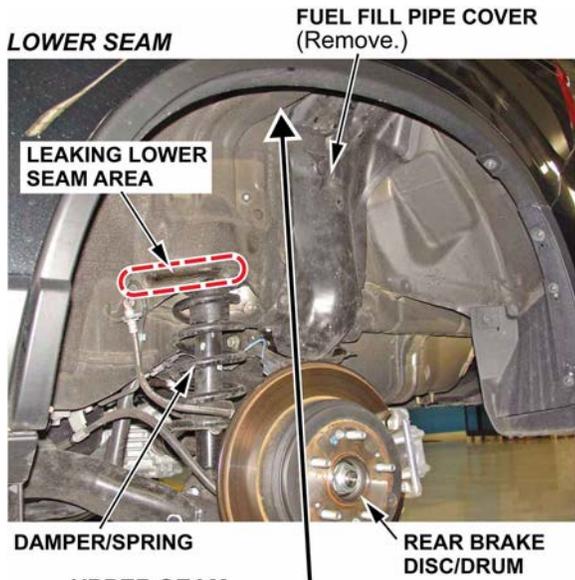
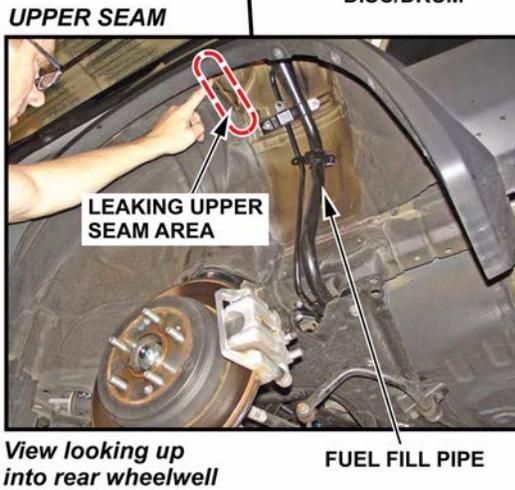
1. With the vehicle on a lift, remove the left rear wheel. Then locate the two areas where the seam sealer will be applied.
