Bulletin No.: PIT5110A

Service Bulletin

Subject: Crank No Start (Check UBEC And Fuel Pump Connector)

Models: 2010-2012 Chevrolet Express Van
2010-2012 GMC Savana Van
With Gas Engine 4.3L, 4.8L, or 6.0L

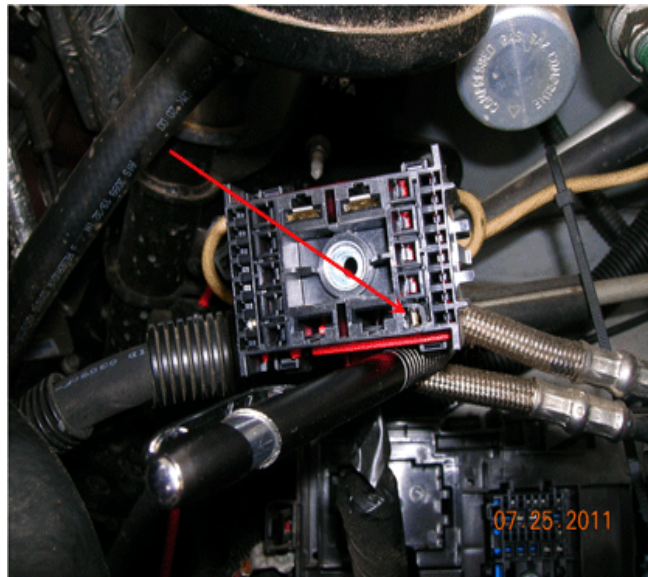
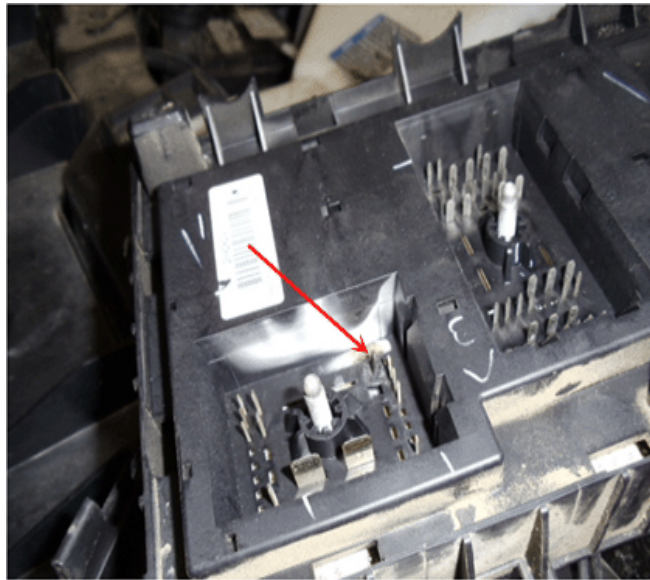
Some owners may comment of a crank no start concern. This concern may be caused by a poor connection in the fuel pump circuits. Inspect the following areas for poor connections:

1. UBEC X2 connector terminal B1, see pic's below (primary area of concern).

1. DO NOT replace the fuel pump for a UBEC connection concern. Use SI connector end view to determine the correct replacement terminal and replace any affected components (UBEC, connector body, wire, etc).
2. Use SI Fuel Pump connector end view to determine the correct replacement terminal or Service connector and repair/replace as necessary. Also, inspect the fuel pump module connector and male terminals for any discoloring or deformation, and if necessary, replace the fuel pump module.
