ITB11-047

## VOLUNTARY SERVICE CAMPAIGN 2011 – 2012 M BLUETOOTH SOUND QUALITY

**CAMPAIGN ID #:** P1239  
**APPLIED VEHICLES:** 2011 – 2012 M37/56 (Y51)  
2012 M35h Hybrid (Y51HV)

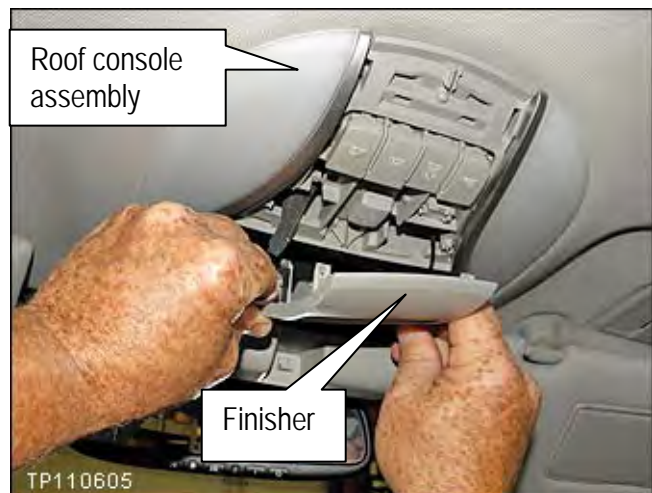
Figure 22

43. Remove / snap loose the finisher shown in Figure 22.

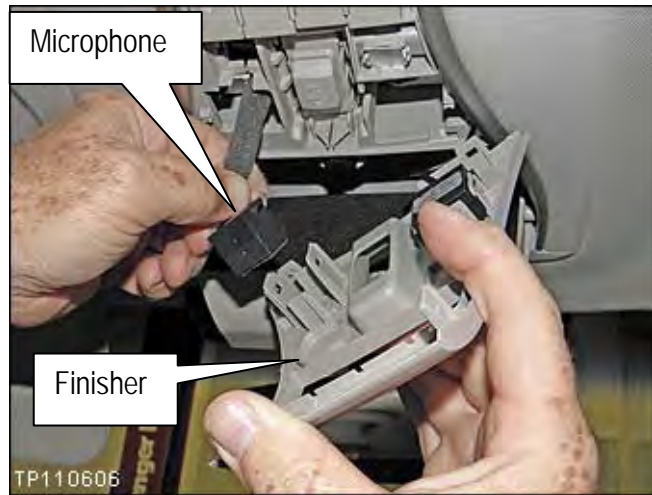
Figure 23

44. Remove the microphone from the finisher.

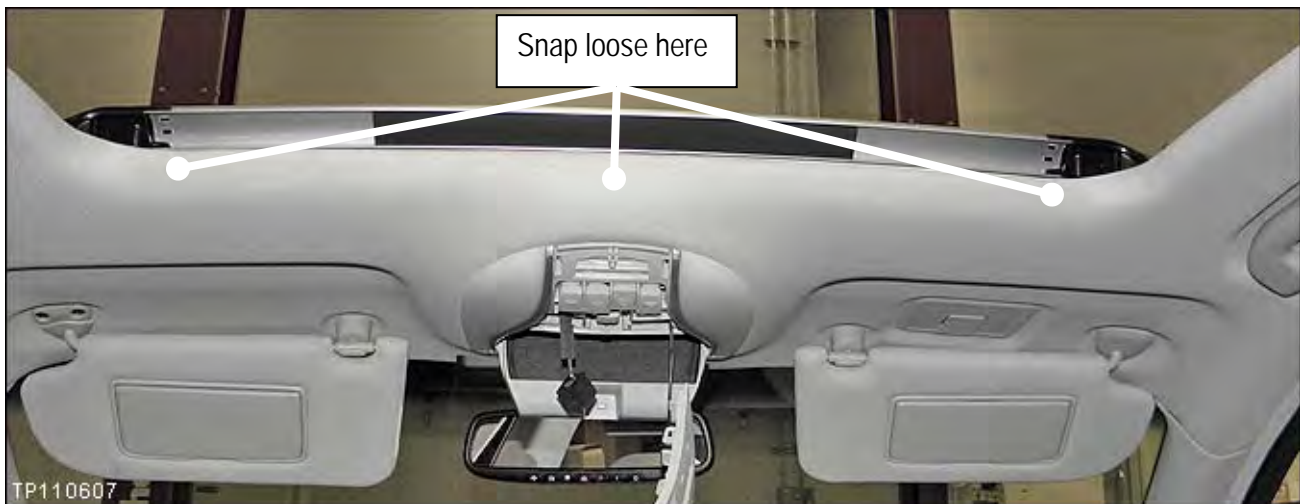
Figure 24

46. Carefully snap loose the headlining along the front of the sunroof opening at the 3 spots shown in Figure 24.

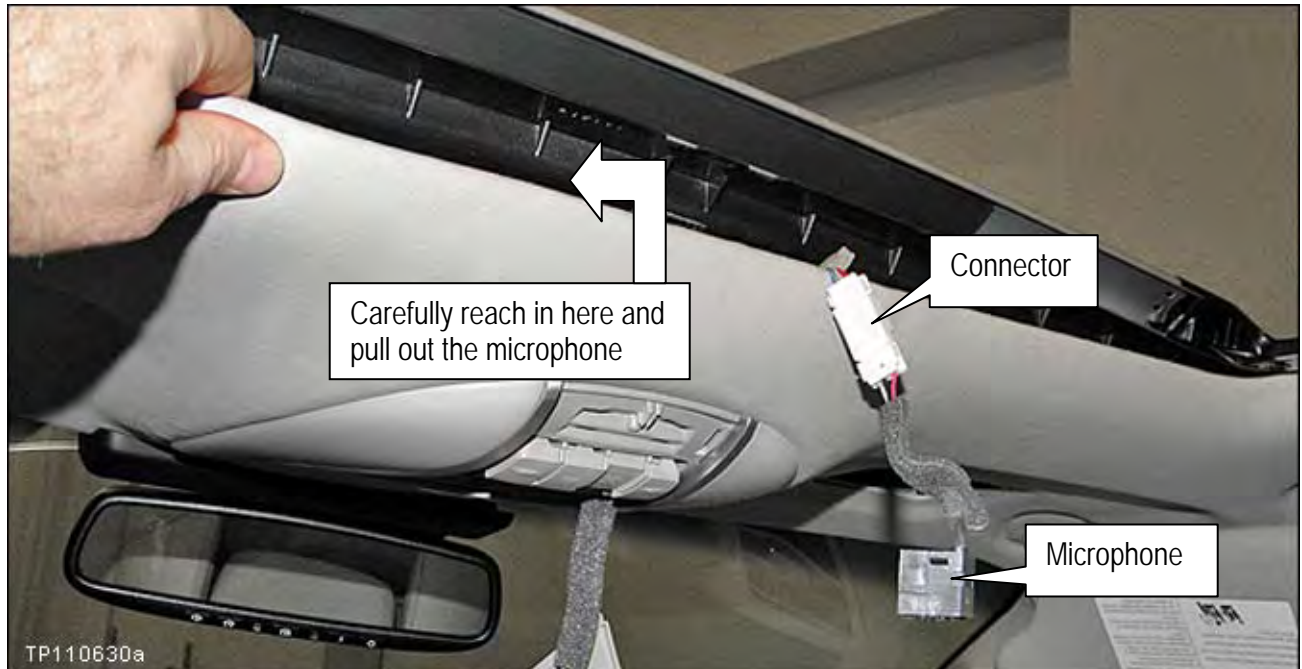
Figure 29

52. Disconnect the old microphone and discard.

53. Install the new microphone in reverse order.

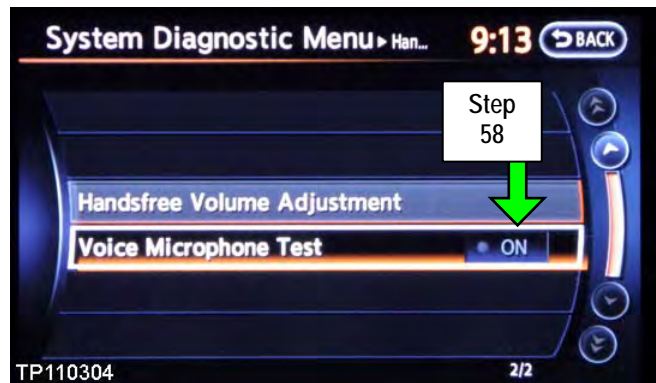
Figure 33

- A "feedback" noise will come from the system speakers as confirmation of microphone operation.
- If you speak, you should hear your voice coming from the system speakers. This is further confirmation of microphone operation.
