Freightliner
Service Bulletin

46-41

Adjusting Tilt Lock Force on TRW Steering Columns

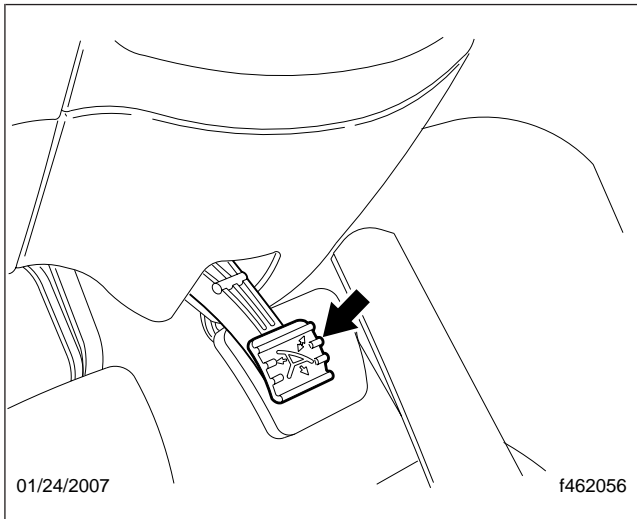
Fig. 1, Foot Pedal on TRW Adjustable Steering Columns.

NOTE: TRW steering columns can be differentiated from other columns by their tilt-adjust foot pedal. See [Fig. 1](#).

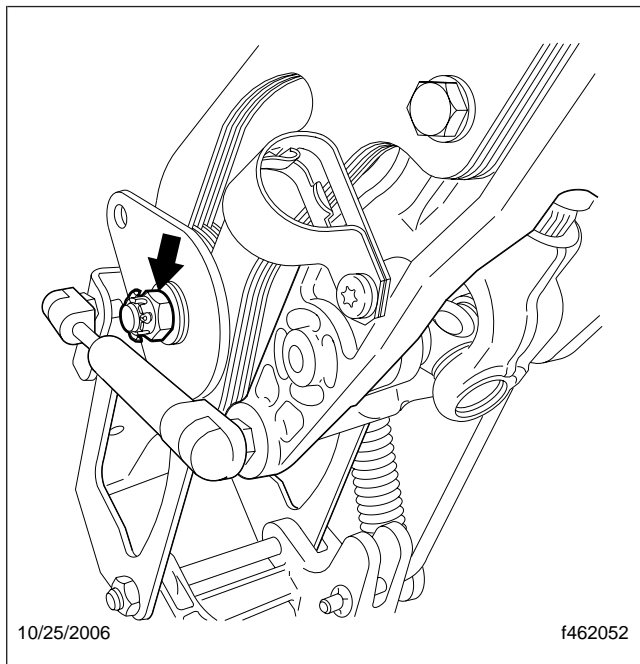
Fig. 3, Castle Nut

Some TRW tilt/telescope steering columns may not have the correct tilt lock force if the column does not hold firmly in place after a tilt adjustment. The castle nut can be tightened to provide the correct force.

6. Locate the castle nut on the left side of the column, and remove the cotter pin. See [Fig. 3](#).
7. Make sure the tilt/telescope adjustment pedal is in the fully locked position, then secure the lock bolt in position using an M8 hex wrench, then tighten the castle nut 85 lbf-in (960 N-cm). See [Fig. 4](#).

8. Install a new 3/32 x 1-inch steel cotter pin at the tightened position, or, if the pin cannot be inserted, tighten the nut to the nearest position which allows installation of the cotter pin. Bend the ends to retain the pin.
