Freightliner  
Service Bulletin

TRW tilt/telescope steering columns in Columbia, Coronado, and Century Class Conventional vehicles may not have the correct tilt lock force if the column does not hold firmly in place after a tilt adjustment. The castle nut can be tightened to provide the correct force.

# Adjusting Tilt Lock Force on TRW Steering Columns

# 46-41

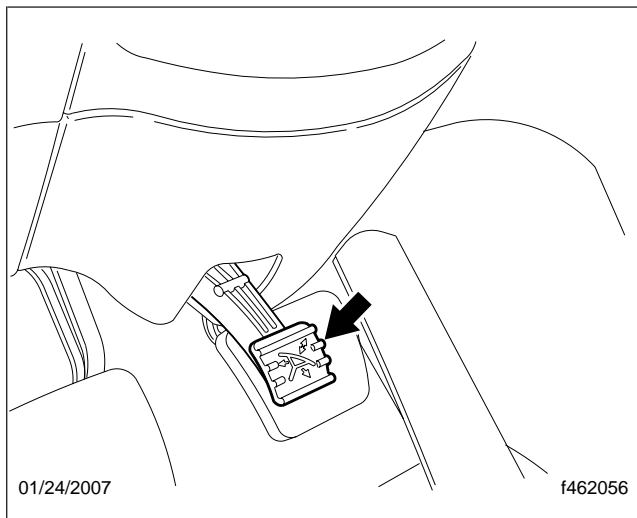
**Fig. 1, Foot Pedal on TRW Adjustable Steering Columns.**

NOTE: TRW steering columns can be differentiated from other columns by their tilt-adjust foot pedal. See [Fig. 1](#).
