Service Bulletin

Bulletin No.: PI0117A

Subject: SIR/Airbag Indicator Light On, DTC B0019 or B0020 Set

Models: 2009-2010 Chevrolet HHR

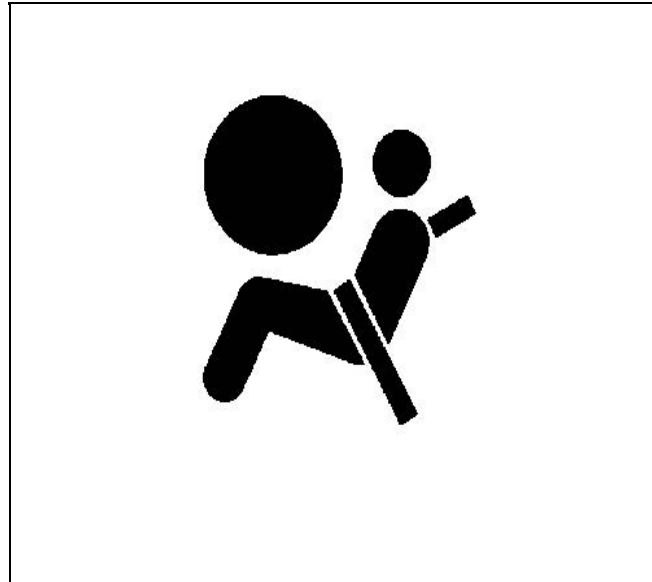
2381215

Note: This concern only involves the SIR/Airbag indicator (shown below). Do not proceed with this bulletin if only the Passenger Airbag indicator is On.

This condition may be caused by fretting corrosion on the terminals of inflatable restraint I/P harness to body harness connector X211 due to excessive vibration.

A new sealed connector has been released.

If a vehicle is encountered with the above condition, follow the procedure below to replace the connector from the body harness to the I/P passenger inflatable restraint harness (X211):
