Applies To: **2012 Odyssey with Navigation** – Check the iN VIN status for eligibility
2012 Pilot with Navigation – Check the iN VIN status for eligibility

December 22, 2011

Product Update: CD or DVD (RES) Restarts When the Ignition Switch Is Turned OFF and ON

(Supersedes 11-070, dated December 15, 2011, to revise the information marked by the black bars)

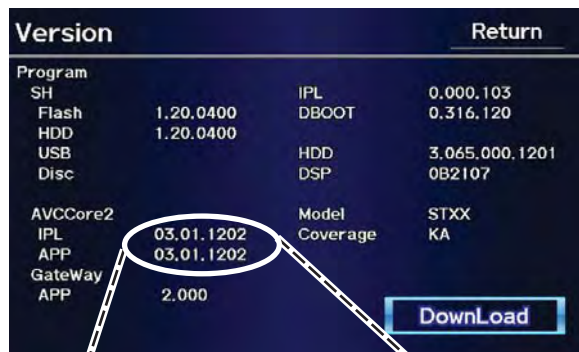
6. Under AVCCore2, check that the fourth digit of the IPL and APP version numbers is **1**.

NOTE: If it is a 2, the AVC software was already updated. Select **Return** to go back to the **Detail Information & Setting** screen, then go to step 5 of the **CD Drive Update**.

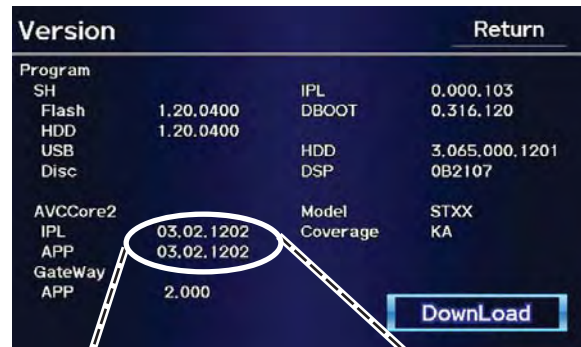
12. Under AVCCore2, check the fourth digit of the IPL and the APP version numbers.

- If it is still 1, turn the ignition switch to LOCK (0), then go to step 1, and repeat the update.
- If it is now 2, turn the ignition switch to LOCK (0), then go to **CD Drive Update**.

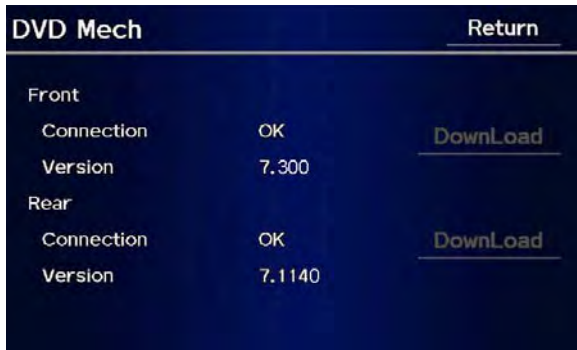
- Confirm that the front mech software version is **7.300**.

- If the vehicle is equipped with RES, go to the **DVD (RES) Drive Update**.
If the vehicle isn't equipped with RES, center-punch a completion mark above the first character of the engine compartment VIN:

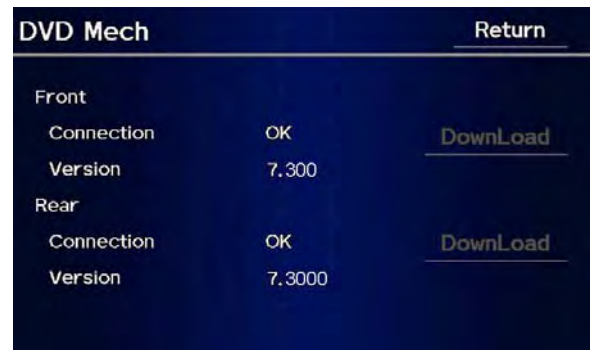
13. Confirm that the rear mech software version is **7.3000**.

14. Center-punch a completion mark above the first character of the engine compartment VIN:
