| <b>Countries:</b> | UNITED STATES,<br>MEXICO | <b>Document ID:</b> | IK1400017 |
| <b>Major System:</b> | REAR AXLE | <b>Created:</b> | 4/13/2012 |

**Applies To: Workstar-Severe Service Models - Latin America Markets All models up to VIN: 672707**

The transverse torque-rod tower bracket on rear axle(s) could fail under severe duty applications.

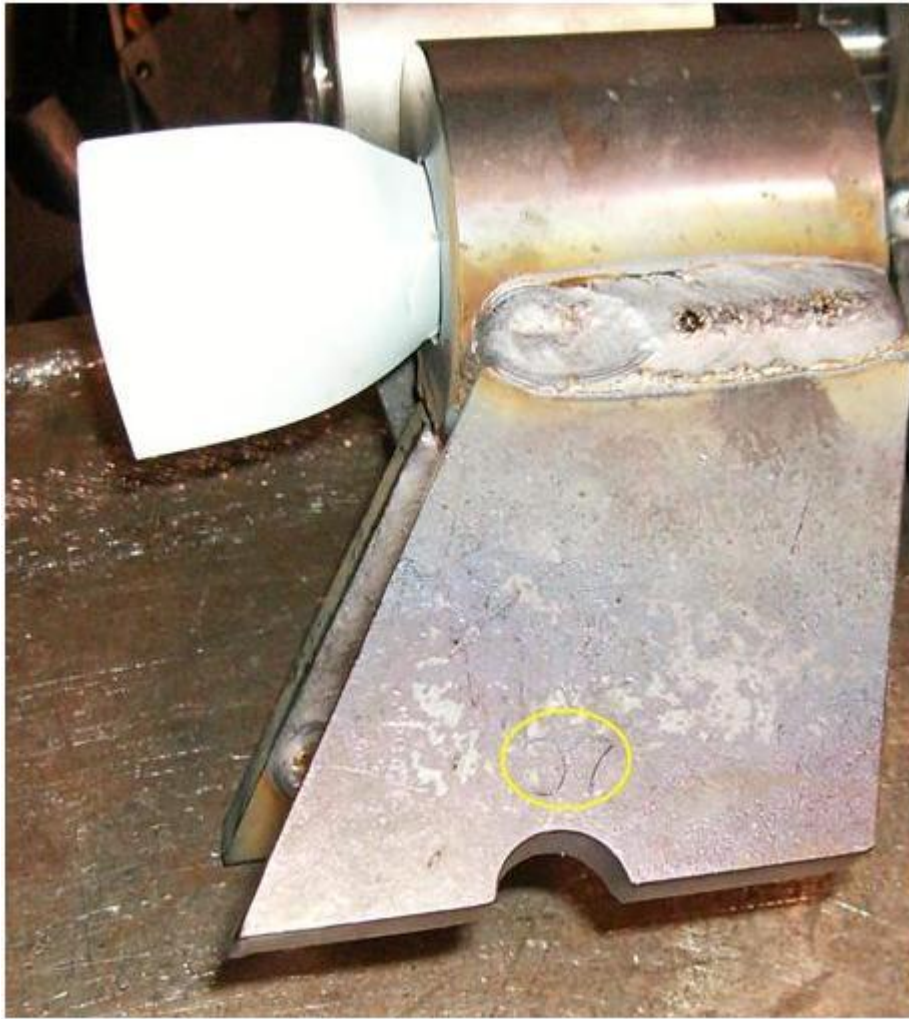
Modified/improved Bracket Identification marking (circled in yellow)

An improved and stronger transverse bracket has been released to address this concern. The improved part can be quickly identified by a marking on the side of the bracket (see picture).

It is important to follow the welding instructions outlined in Navistar's Publication.
