SUBJECT: Service Update for Inventory and Customer Vehicles
Driver Airbag Inspection - Expires with Base Warranty

MODELS: 2012 Chevrolet Cruze

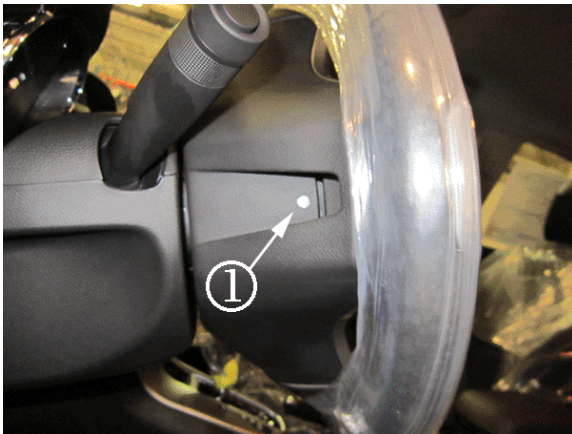
2759759

1. Determine if the steering wheel inflatable restraint module has been inspected and repaired. Turn the steering wheel 90 degrees to the right and look for a white dot (1) in the recessed pocket area on the back side of the steering wheel spoke.
 - If a white dot is NOT present, proceed to step 2.
 - If a white dot is present, no further action is required.
2. Disable the supplemental inflatable restraint (SIR) system. Refer to *SIR Disabling and Enabling* in SI.
3. Turn steering wheel 180 degrees to access the module release points on top of the column.
4. Insert suitable tools to the openings on both sides of the steering wheel.
5. Release the springs in direction of the arrows.

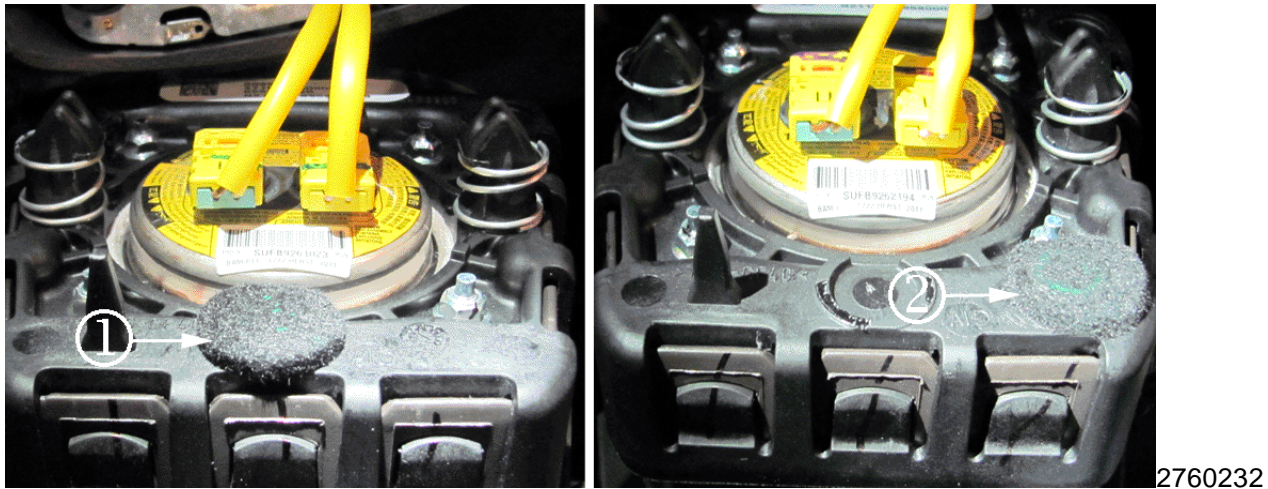
This bulletin provides a service procedure to inspect and ensure that the driver airbag module retainers are fully engaged in the steering wheel on **certain** 2012 model year Chevrolet Cruze vehicles. On some of these vehicles, the driver's side airbag module retainers may not be fully engaged due to interference with a felt insulator patch.

6. Remove the felt patch from the 6 o'clock position (1) and re-install it in the 5 o'clock position (2) as shown in illustration. The felt patch edge should be in line with the edge of the airbag module. The felt patch should not hang over the airbag module edge.
7. Align the steering wheel module fasteners to the steering column fastener holes.
