# Service Bulletin

**SUBJECT:** Service Update for Inventory and Customer Vehicles  
Driver Airbag Inspection - Expires with Base Warranty

**MODELS:** 2012 Chevrolet Cruze

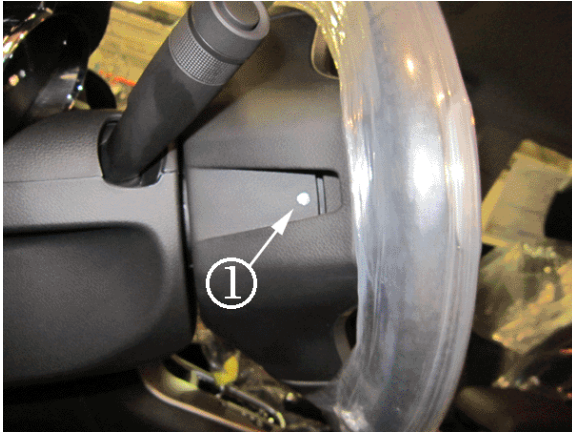
This bulletin provides a service procedure to inspect and ensure that the driver airbag module retainers are fully engaged in the steering wheel on **certain** 2012 model year Chevrolet Cruze vehicles. On some of these vehicles, the driver's side airbag module retainers may not be fully engaged due to interference with a felt insulator patch.

1. Determine if the steering wheel inflatable restraint module has been inspected and repaired. Turn the steering wheel 90 degrees to the right and look for a white dot (1) in the recessed pocket area on the back side of the steering wheel spoke.
  - If a white dot is NOT present, proceed to step 2.
  - If a white dot is present, no further action is required.
2. Disable the supplemental inflatable restraint (SIR) system. Refer to *SIR Disabling and Enabling* in SI.
3. Turn steering wheel 180 degrees to access the module release points on top of the column.
4. Insert suitable tools to the openings on both sides of the steering wheel.
5. Release the springs in direction of the arrows.
