Bulletin No.: PI0660

Service Bulletin

Subject: Malfunction Indicator Lamp (MIL) Intermittent Illumination, Throttle Body Outside Air Inlet Duct Cracks

Models: 2009-2011 Chevrolet Aveo
2009 Pontiac G3
2009 Pontiac G3 Wave (Canada)
2010 Pontiac G3 (Canada)
Equipped with Engine RPO LXV

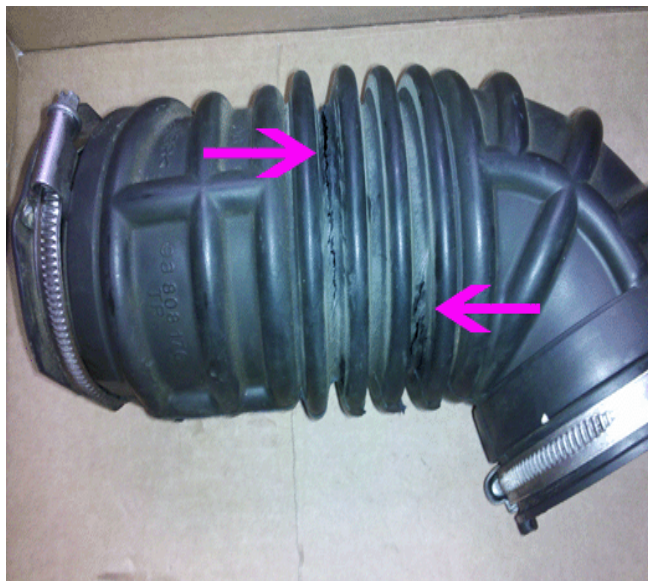
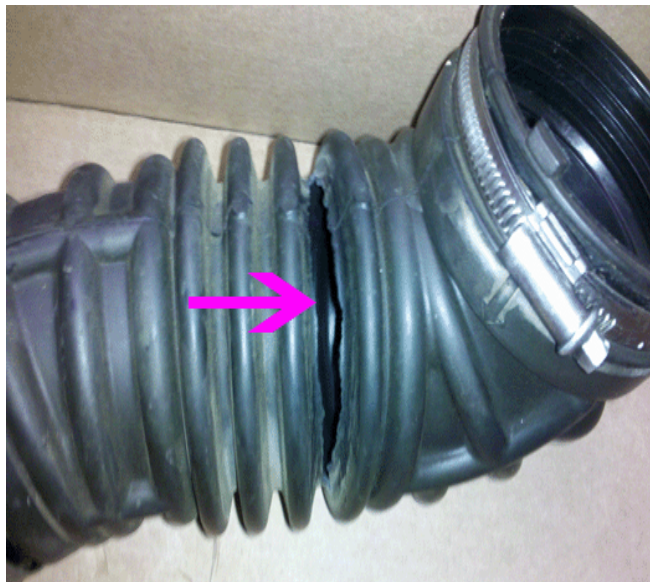
2754649

Some customers may comment on an intermittent illuminated malfunction indicator lamp (MIL). This condition may be caused by cracks in the throttle body (TB) outside air inlet duct.

5. Manipulate the TB outside air inlet duct while performing a visual inspection for any cracks, separations or deterioration as shown.
 - ⇒ If any cracks, separation or deterioration are observed, replace the TB outside air inlet duct.
6. Install and tighten the air cleaner assembly and TB clamps.
7. Connect the breather hose to the TB outside air inlet duct, if equipped.
8. Connect the battery negative cable. Refer to Battery Negative Cable Disconnection and Connection in SI.
9. Turn ON the ignition.
10. Clear any DTCs with a scan tool.
