Service Bulletin

Bulletin No.: PIC5625A

Subject: Steering Sensitive At Highway Speed / Sensitive To Wind At Highway Speed

Models: 2012 Chevrolet Sonic

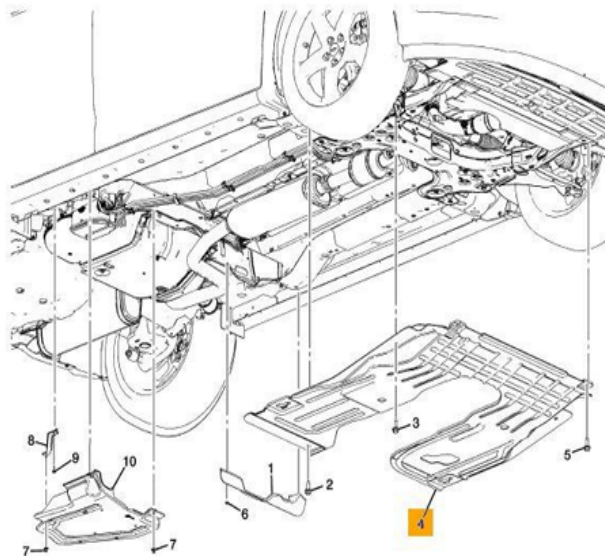
2761635

A customer may have a concern that while driving on the highway, and although the steering wheel is properly centered, they are finding themselves having to make slight steering corrections at times while driving straight down the road. A customer may also state that the steering is sensitive or more responsive than they are used to from past driving experience.

On vehicles built prior to January 1, 2012, dealers are instructed to remove the vehicle belly pan, which may cause the vehicle to be more sensitive to high speed airflow, and re-evaluate the concern. If the concern is no longer present, no further repairs are required at this time. If concern is still present, or if the vehicle was built after January 1, 2012, contact General Motors Technical Assistance for further direction.
