# Service Bulletin

Bulletin No.: PIC5626

**Subject:** BAS+ (Hybrid) eAssist Service Charging System Message MIL On With P0A8F And P062F Or Without DTCs

**Models:** 2012 Buick LaCrosse eAssist  
 2012 Buick Regal eAssist  
 2013 Chevrolet Malibu ECO eAssist  
 All with RPO HP6

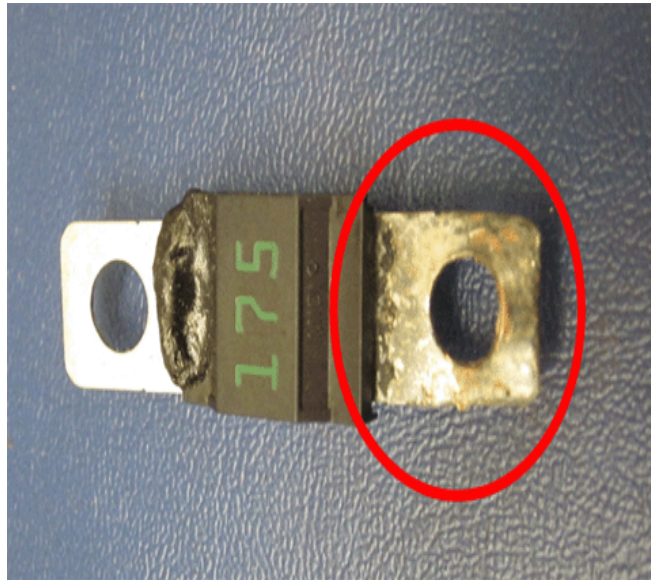
2754391

If the fuses are within specifications, inspect around the edge of the black plastic portion of these fuses for any sign of voltage stress as shown in the photo below. Make sure that the metal blades of the fuse are not bent or showing signs of thermal damage.

If the fuses show voltage stress is present, this is most likely the result of a poor connection. The Fuses are now available individually. If the entire fuse block needs to be replaced for any reason the fuse block includes both fuses.

If the fuses have been removed, they can be reused if they pass the inspection above and they are not visually damaged in any way. Carefully torque them to 4.7 Nm (42 lb-in), and re-evaluate the charging system operation. If the 175A fuse is open or has a poor connection, a P0A8F may be stored in history but the DTC may not consistently reset.
