Service Bulletin

PRELIMINARY INFORMATION

Subject: BAS+ (HYBRID) eAssist Charge Message On After Collision Or Low Voltage Condition

Models: 2012 Buick Lacrosse eAssist
 2012 Buick Regal eAssist
 2013 Chevrolet Malibu ECO eAssis
 tAll with RPO HP6

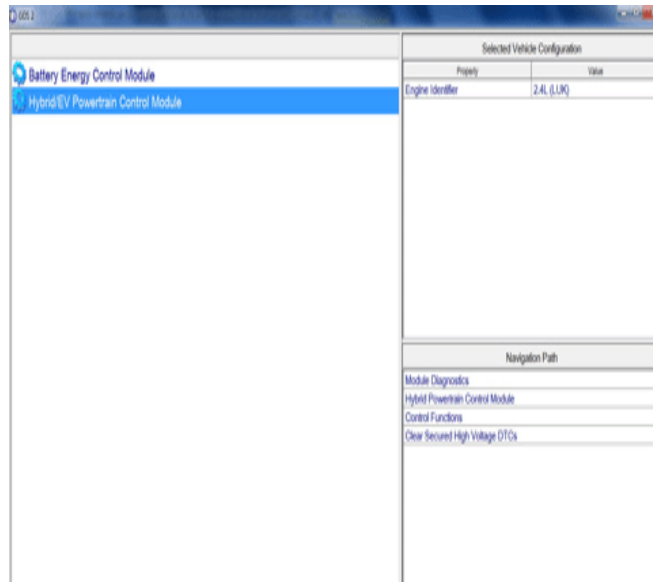
There is a Service Charging System message, MIL, and/or charging system may be inoperative with no related DTCs. In some cases, this may be the result of a vehicle collision that caused the contactors to open.

If this concern is encountered, start GDS2 and ensure that engine identifier LUK has been selected as shown in the screen print below so the HPCM (Hybrid Powertrain Control Module) can be accessed to read hybrid DTCs. There may not be any DTCs set and all repairs have been performed to repair the original concern. This may have occurred due to extremely low system voltage.
