Technical Service Bulletin

94 A7 Cornering light intermittently does not work

94 12 67 2028664/1 February 15, 2012.

Model(s)	Year	VIN Range	Vehicle-Specific Equipment
A7	2012	Not Applicable	Not Applicable

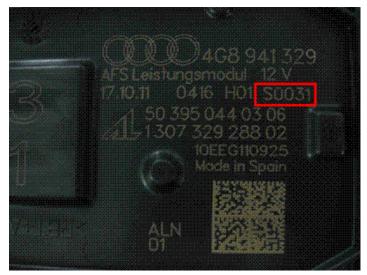
Figure 1. Software version SW 0031.

- 1. Replace the cornering light module
- The new control unit must have software version SW 0031. This must be checked on the control unit (Figure 1).
