Technical Service Bulletin

21C5 UPDATE - Replace Coolant Supply Line (NVLW)

21 12 07 2020953/5 February 14, 2012. Supersedes Technical Service Bulletin Group 21 number 11 - 04 dated July 13, 2011 for reasons listed below.

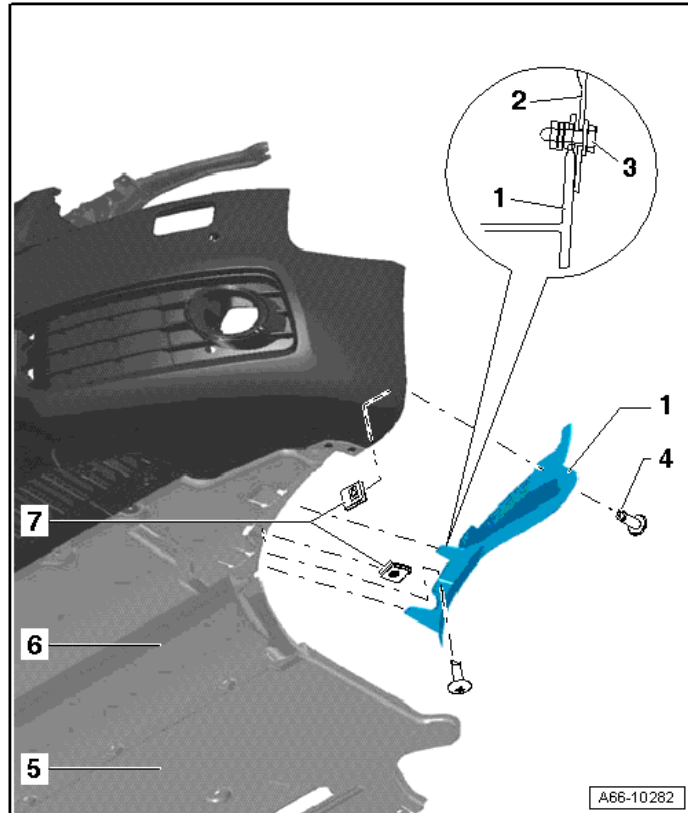
Figure 1. The wheel spoiler (1).

1. Remove wheel spoiler (Figure 1, 1).

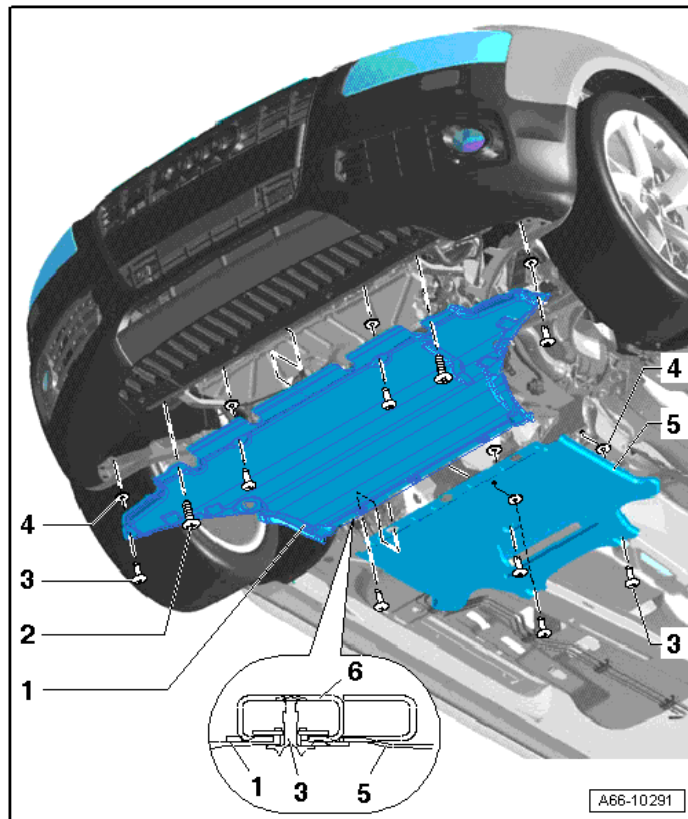
Figure 2. Front noise insulation (1).

2. Remove front noise insulation (Figure 2, 1).

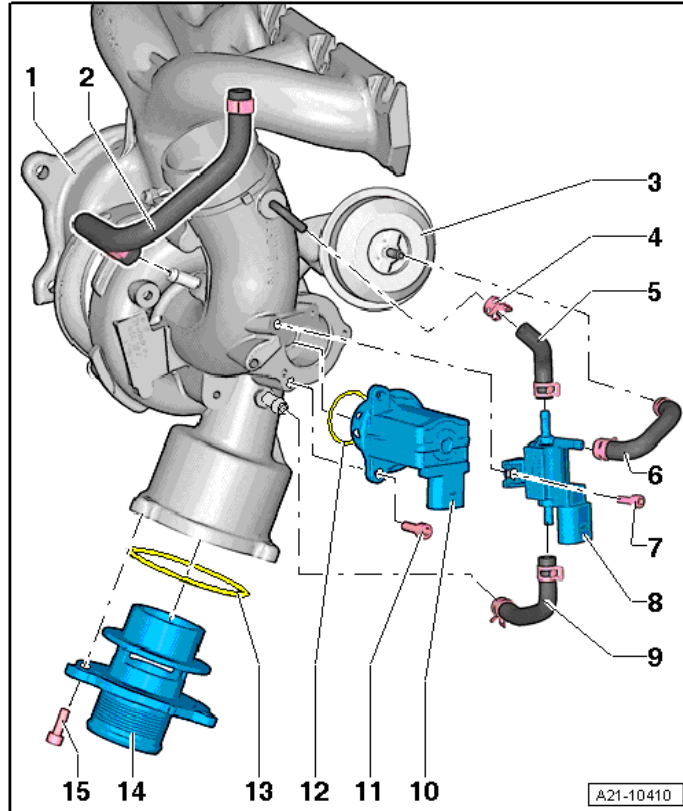
Figure 3. The turbocharger air recirculation valve N249 (10), bolt (11), and connection (14).

4. For greater access to the coolant supply line:
 - a. Remove turbocharger air recirculation valve N249 (Figure 3, 10).
Tightening torque for bolt (Figure 3, 11): 9 Nm.
 - b. Detach charge air pressure hose from connection (Figure 3, 14).

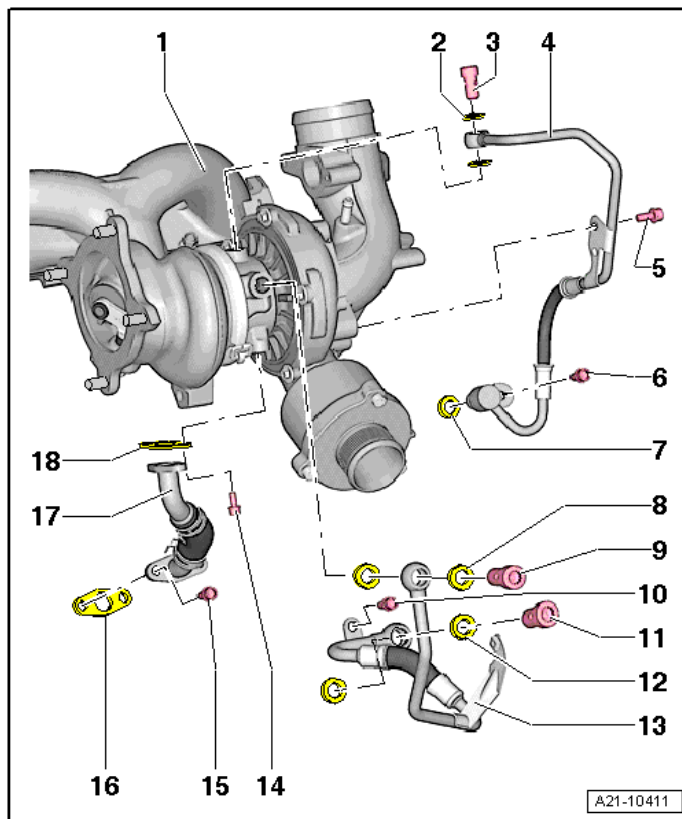
It is possible that the coolant supply line at the turbocharger may leak on Audi vehicles with 2.0L TFSI engines built within a specific period.

Figure 4. The seals (8, 12), bolts (9-11), and coolant supply line (13).

5. Remove coolant supply line (Figure 4, 13), including seals (Figure 4, points 8 and 12).

Save the heat shield from the old coolant supply line.

6. Replace coolant supply line (Figure 4, 13), including seals (Figure 4, points 8 and 12).
Transfer the heat shield from the old coolant supply line to the new coolant supply line.

Without the heat shield, the new hose can be damaged due to excessive heat exposure.

- Bolt (Figure 4, 9): 20 Nm + 45°.
- Bolt (Figure 4, 10): 9 Nm.
- Bolt (Figure 4, 11): 20 Nm + 45°.
